# HISTORIC DISTRICT COMMISSION MEETING AGENDA

To: Historic District Commission  
From: R. Brent Savidant, Planning Director  
Subject: Notice to Proceed – Demolition of Building Additions – Old Stone School –  
3995 South Boulevard

Linda Rivetto  
Principles of Preservation Technology  
GHPR591  
Exterior Assessment Conditions Report  
8 March 2004

# **OLD STONE SCHOOL**

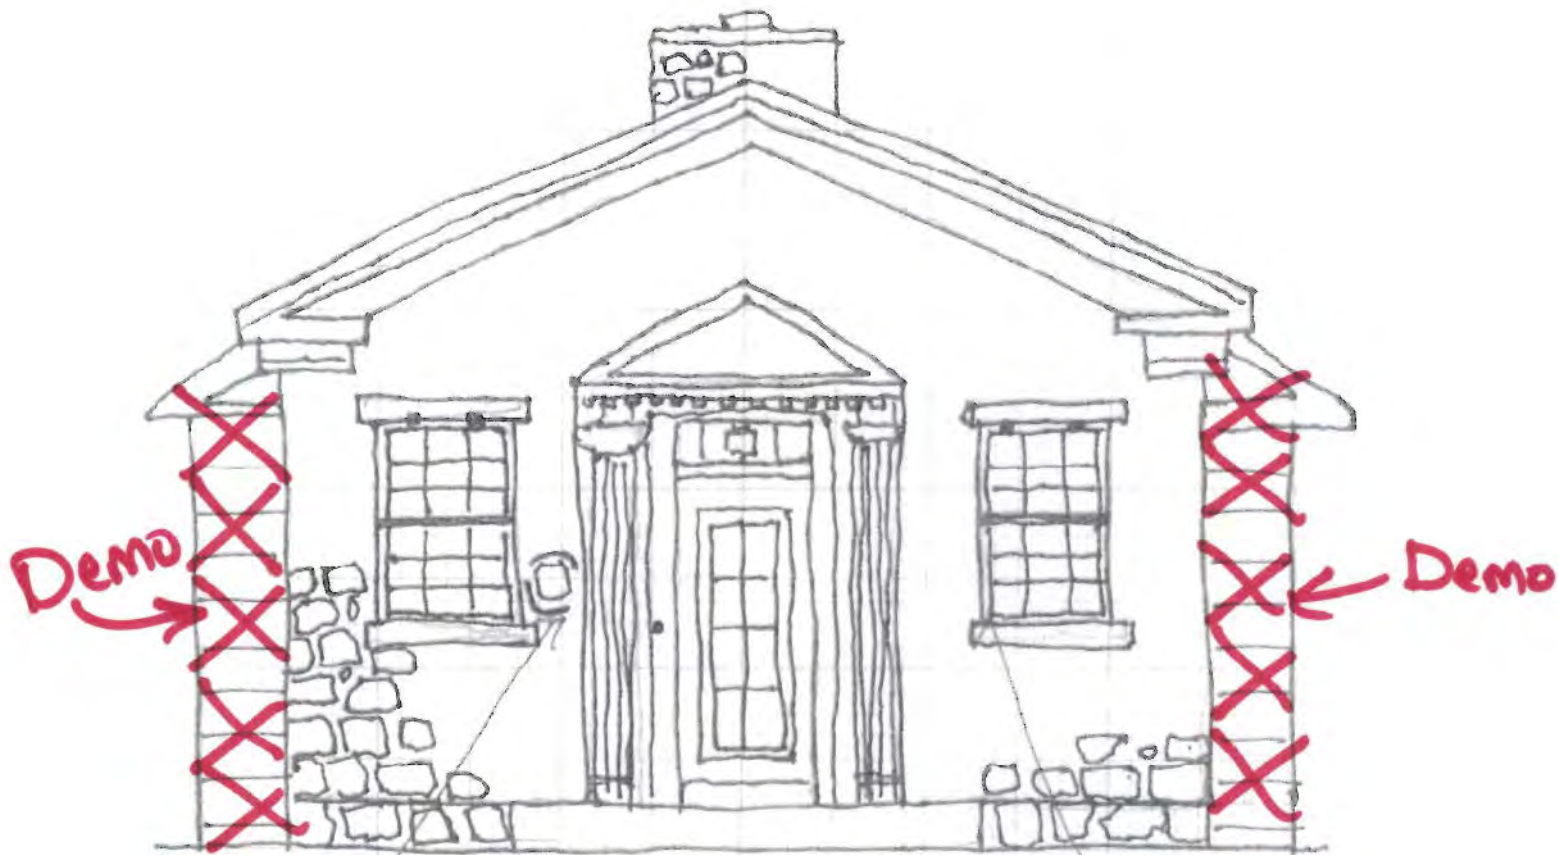
North Elevation

mortar crack

storm window warped

shrubs obstructing doorway

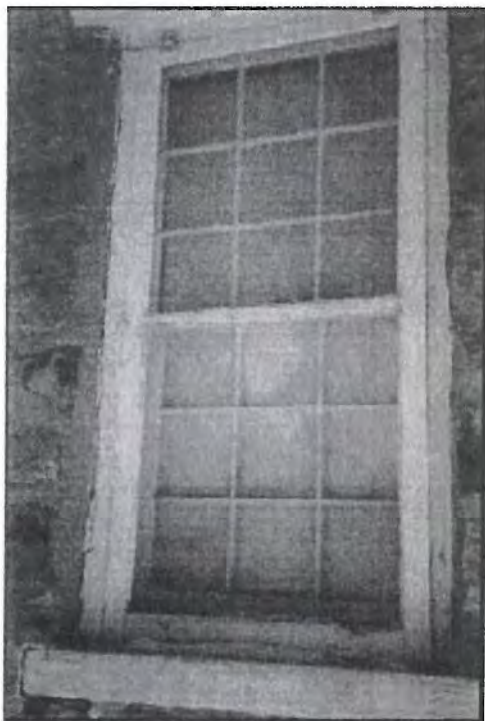
Photo No. 20  
Window  
Stone School

Windows: All of the windows and storm windows show signs of weathering. The paint is peeling on every window and frame, as well as on the lintels and sills on the stone structure. Also, there has been some warping of the storm windows, especially on the stone building (photos 20-22). There is broken window on the south side of the building (photo 23).

Windows: As all the windows, with their glass, on the schoolhouse are original, it is desirable to repair them, rather than replace them. The varying conditions of the windows would suggest that all of the repair classes in Preservation Brief No. 9 would probably be used (Myers). Some might only need minor work, others need more stabilizing, and there are a few that have missing woodwork. It would be necessary to use the assistance of a professional who is knowledgeable about historic windows.
