HISTORIC DISTRICT COMMISSION MEETING AGENDA

February 18, 2021

Historic Outhouse Inspection Report

Located at: 3995 W South Blvd.

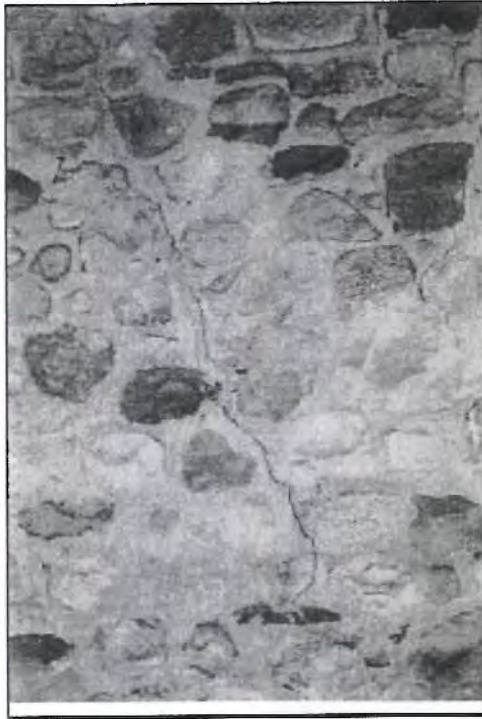
Photo No. 13
Crack in Mortar
Stone School

Walls: The stone walls of the schoolhouse are in basically very sound condition. There are mortar cracks on all walls (photos 13, 14). However, there is no indication of a problem caused by these cracks on the interior of the structure. The addition has painted wood siding, which is showing much evidence of weathering and peeling (photo 15).

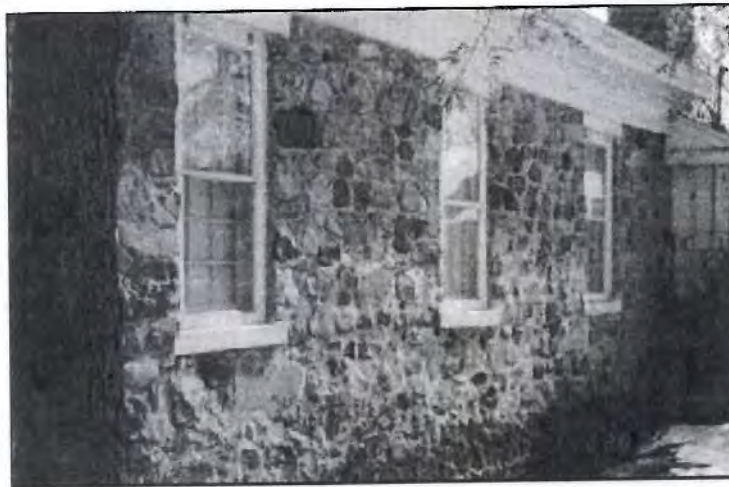
Photo No. 16
West Side Foundation
Stone School

Foundation: The stone foundation of the schoolhouse appears dark along both sides of the building (photos 16, 17). It is probable that this is a sign of rising damp. There was no immediate evidence of a problem in this area on the interior of the building. The concrete block foundation of the addition seemed to be in good condition, showing no specific problems (photos 18, 19).

The major cause of deterioration on all parts of this building is water. All wood components show signs of weathering due to rain and snow. The rising damp of the foundation is a result of the roofline draining water very close to the foundation and of the foundation touching the ground. The lack of downspouts and poor condition of the existing gutters adds to the ground drainage problem. The interior ceiling damage is a result of some leakage problem in the roof. The cracked mortar is a result of aging and weathering. The ice dams and icicles, though, are a result of poor or no insulation in the attic areas (photos 24, 25).

Foundation: Because of the possibility of rising damp on the foundation of the stone structure, there is a need to look closely at the water drainage from the building and on the site in general. This location is at Troy’s highest elevation, at 860 feet (Lance 20), so a high water table should not be an issue. However, drainage from the roofline could be a problem, due to the lack of gutters and downspouts.

There could be a need to grade the ground line around the building to facilitate water drainage away from the building (Park 14). Consideration should also be given to historic ways to handle water runoff from the roofline: if gutters and downspouts were not commonly used, and there is not indication of their use on this structure, there may be historic methods used to divert water from building foundations. This would require more research, and perhaps the enlisting of the aid of an expert in the field of moisture control.

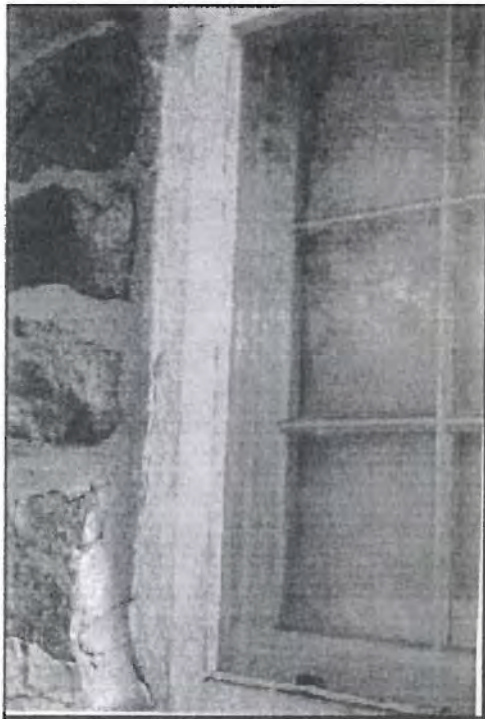
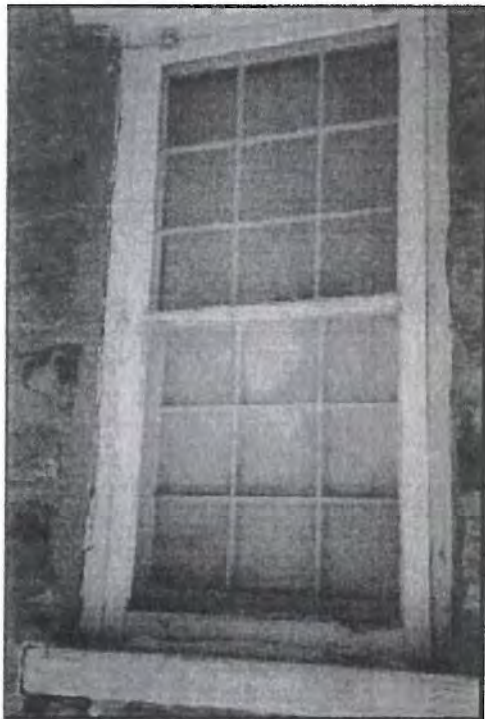
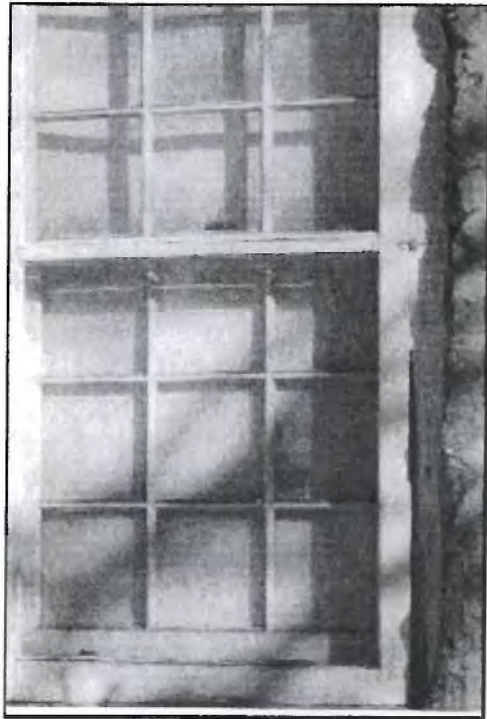
Windows: All of the windows and storm windows show signs of weathering. The paint is peeling on every window and frame, as well as on the lintels and sills on the stone structure. Also, there has been some warping of the storm windows, especially on the stone building (photos 20-22). There is broken window on the south side of the building (photo 23).

Windows: As all the windows, with their glass, on the schoolhouse are original, it is desirable to repair them, rather than replace them. The varying conditions of the windows would suggest that all of the repair classes in Preservation Brief No. 9 would probably be used (Myers). Some might only need minor work, others need more stabilizing, and there are a few that have missing woodwork. It would be necessary to use the assistance of a professional who is knowledgeable about historic windows.

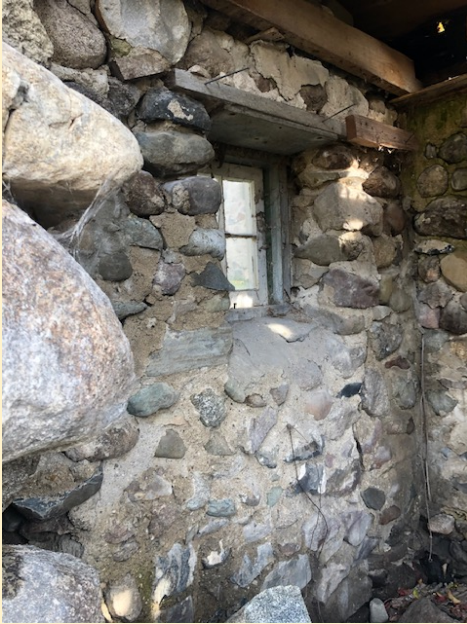
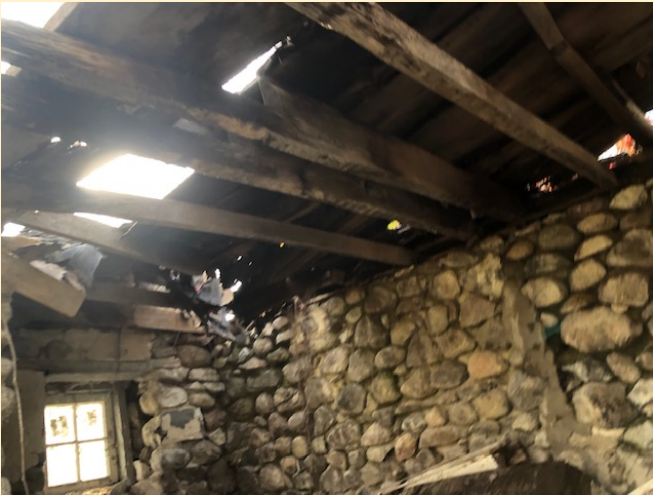
The Out House presents partial structural failure on all walls. The east wall has collapsed to the ground with missing stone material from the site and the north and south walls are still standing with structural

cracks from the footing to the roof structure supports. The west wall is apparently firm, however full access to view it was not possible.

- 1) The structure must be secured by a temporary link fence, with a permanent “No trespassing sign”.
- 2) The weeds and brush around it must be cleared from the area.
- 3) The fallen wood members and general debris must be removed from the area, to prevent the proliferation of rodents.

- 4) All structural members that are not stable, must be taken down to the ground and salvaged for future use.
- 5) The roof material would need to be disposed of after approval from the Historic District Commission.
- 6) The walls will have to be braced and secured to prevent a collapse.
- 7) All the work to be performed must be executed by a Licensed Contractor and a demolition permit must be secured before the work starts.

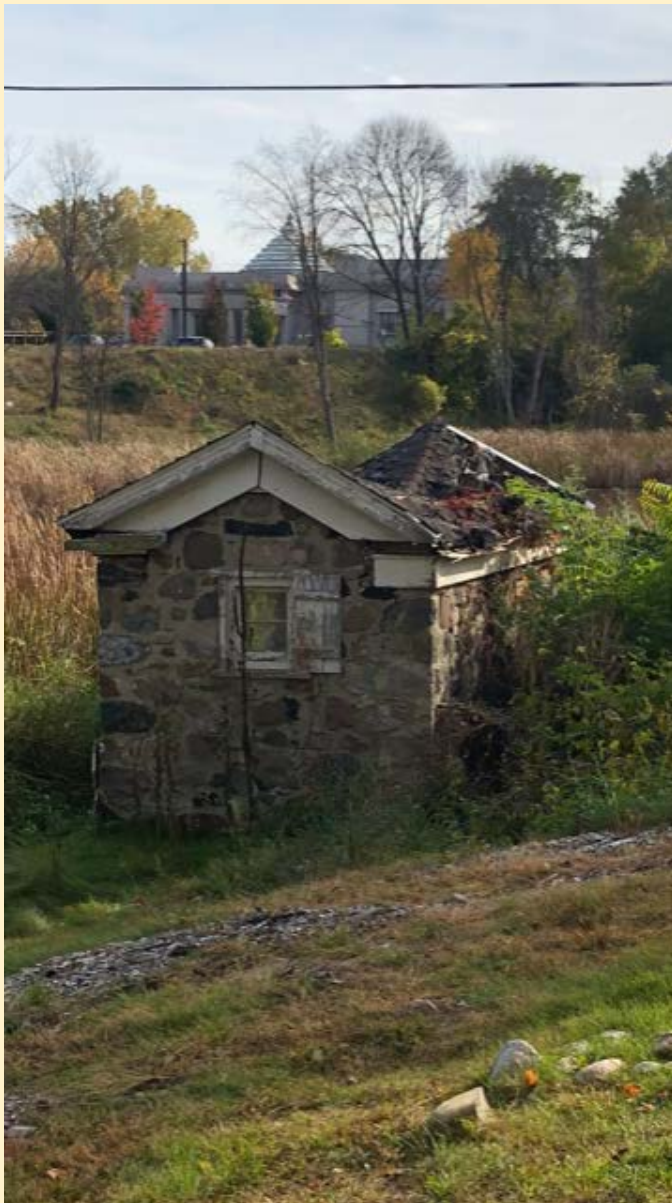
The roof structure presents apparent fire damage by possible brush control fires. The timber beams are still up and holding with a potential fatigue the secondary roof structural members. All roof shingles are damaged either by exposure to the elements and/or fire. The frieze,

facia trim and windows, appear in good physical condition in relation to the general exposure to the elements.

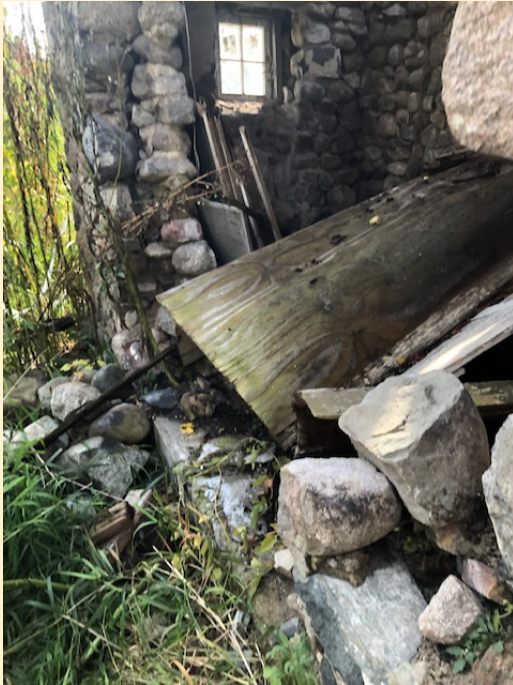
The presence of this structure as it is now standing represents a potential risk for the life and safety of the City of Troy residents.

It is a dangerous building and contains multiple violations of the Michigan Building Code 2015 and the City of Troy Ordinance.

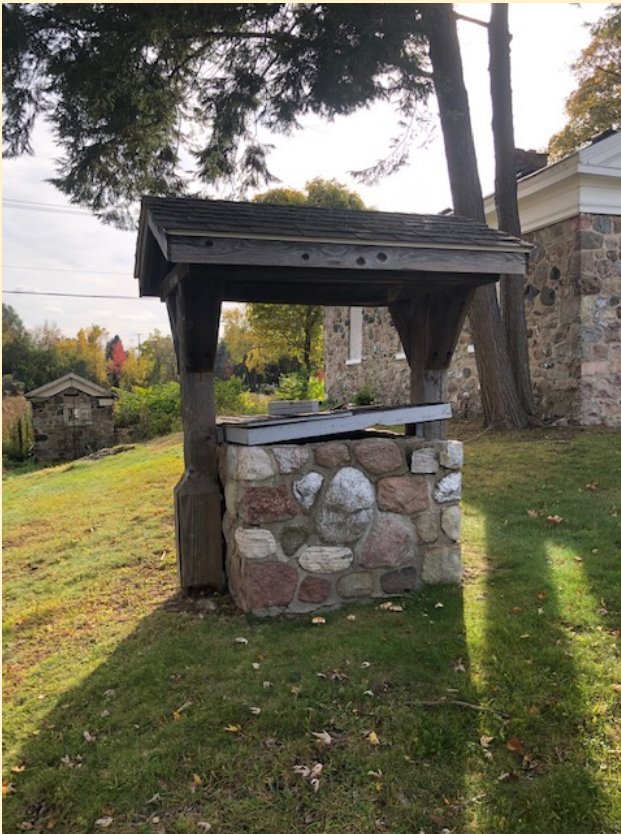
The Water Well- At the present time it is not secured. Therefore, representing a high risk to the life and safety of the Troy residents.

- 1) The lid must be of a metal structural material with a lock.
- 2) The present lid can stay on top of the structural grill.
