Historic District Committee- Agenda Item

Date: February 12, 2021
To: Historic District Commission Members
From: R. Brent Savidant, Community Development Director
Subject: Demolition of Outhouse – Old Stone School (3995 W. South Boulevard)

Linda Rivetto
Principles of Preservation Technology
GHPR591
Exterior Assessment Conditions Report
8 March 2004

Historic Outhouse Inspection Report

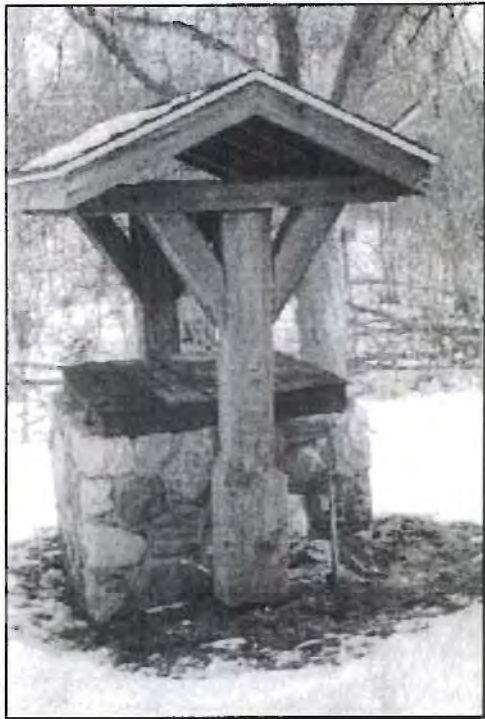
Photo No.2
Well
Stone School

There are 3 other structures on the site: a well (photo 2), whose top is currently covered with a wood panel; a stone outhouse with two doors which are original (photo 3); and a part stone/part wood garage – the stone part built in the 1950s with the same stone as the schoolhouse, which was found on the site, and the wood part added on about 1980. The stone section of the garage has been turned into a small apartment, with a kitchen and bathroom.

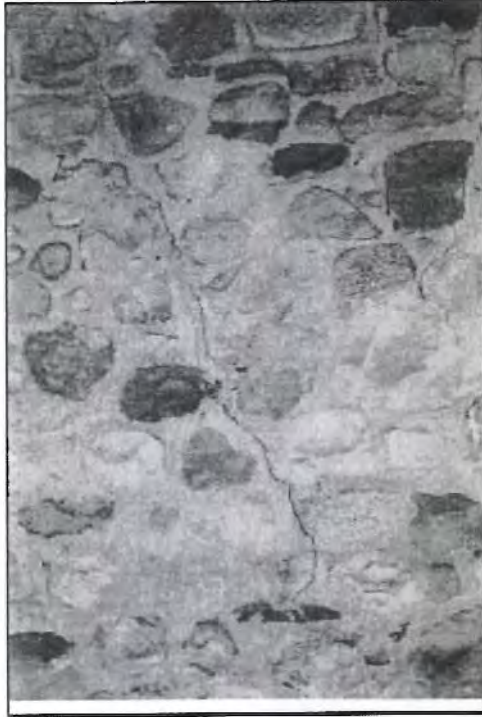
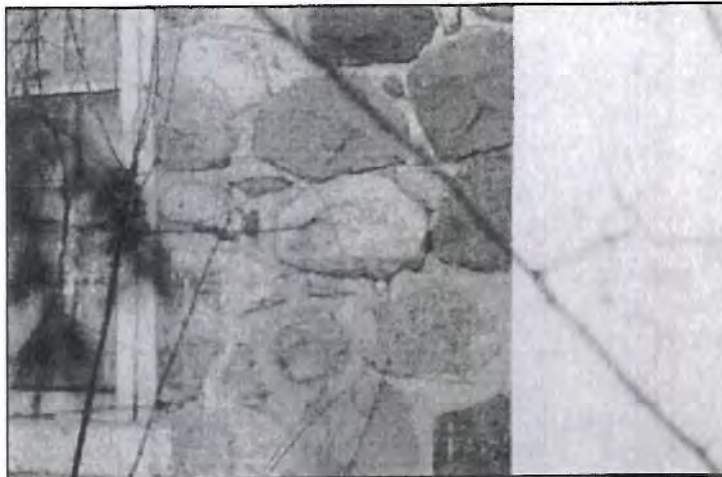
Walls: The stone walls of the schoolhouse are in basically very sound condition. There are mortar cracks on all walls (photos 13, 14). However, there is no indication of a problem caused by these cracks on the interior of the structure. The addition has painted wood siding, which is showing much evidence of weathering and peeling (photo 15).

Walls: The masonry needs some repointing, which would require a thorough research into the type of mortar used originally on the structure. It is important to match the new mortar to the old so that each individual part of the structure responds to stresses in the same way, and so that the new mortar is “sympathetic, supportive, and, if necessary, sacrificial” to the old mortar (Mack 4). An expert should be called in to do the analysis and to determine the correct mortar.

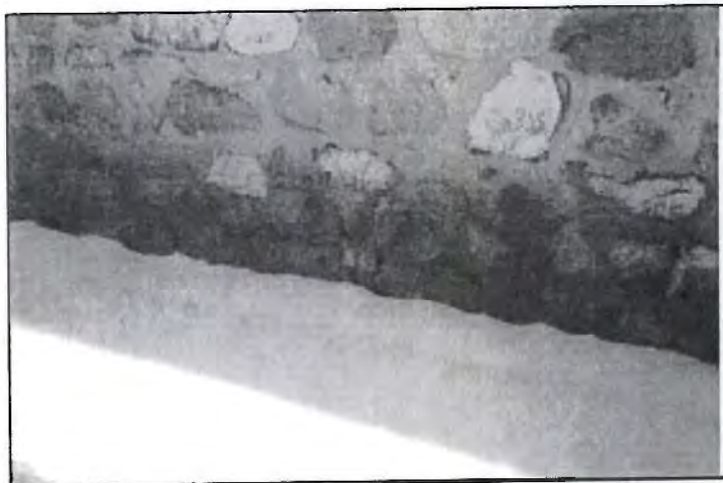
Foundation: The stone foundation of the schoolhouse appears dark along both sides of the building (photos 16, 17). It is probable that this is a sign of rising damp. There was no immediate evidence of a problem in this area on the interior of the building. The concrete block foundation of the addition seemed to be in good condition, showing no specific problems (photos 18, 19).

Foundation: Because of the possibility of rising damp on the foundation of the stone structure, there is a need to look closely at the water drainage from the building and on the site in general. This location is at Troy’s highest elevation, at 860 feet (Lance 20), so a high water table should not be an issue. However, drainage from the roofline could be a problem, due to the lack of gutters and downspouts.

There could be a need to grade the ground line around the building to facilitate water drainage away from the building (Park 14). Consideration should also be given to historic ways to handle water runoff from the roofline: if gutters and downspouts were not commonly used, and there is not indication of their use on this structure, there may be historic methods used to divert water from building foundations. This would require more research, and perhaps the enlisting of the aid of an expert in the field of moisture control.

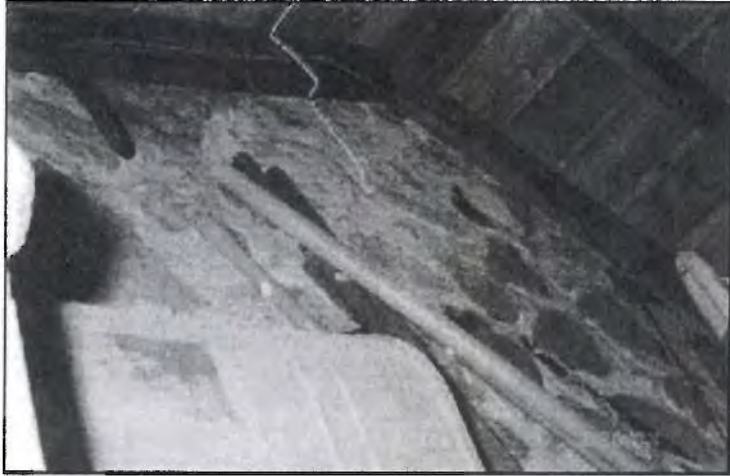
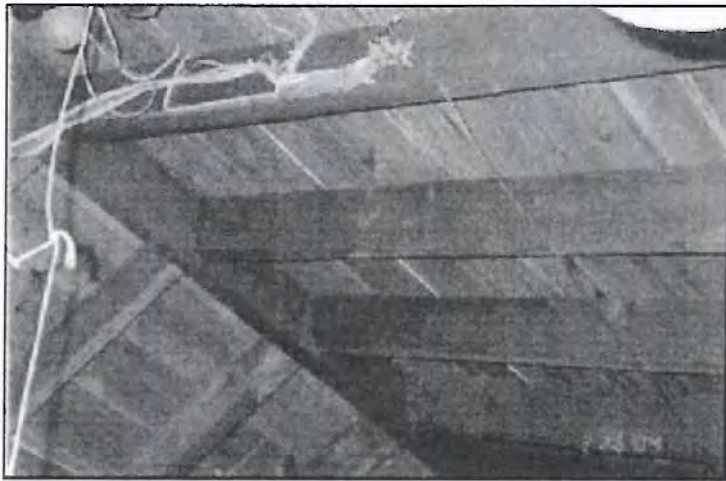
The major cause of deterioration on all parts of this building is water. All wood components show signs of weathering due to rain and snow. The rising damp of the foundation is a result of the roofline draining water very close to the foundation and of the foundation touching the ground. The lack of downspouts and poor condition of the existing gutters adds to the ground drainage problem. The interior ceiling damage is a result of some leakage problem in the roof. The cracked mortar is a result of aging and weathering. The ice dams and icicles, though, are a result of poor or no insulation in the attic areas (photos 24, 25).

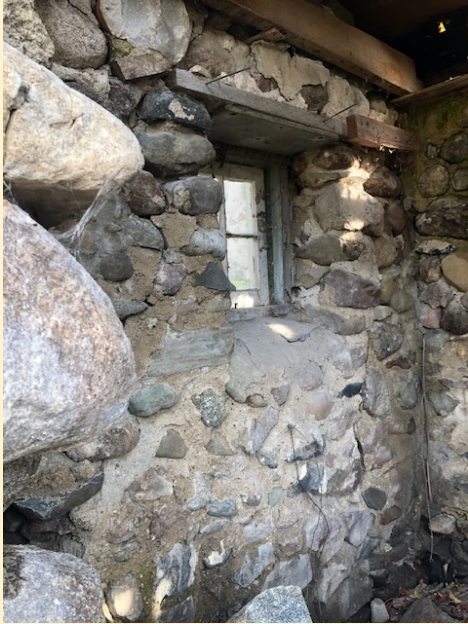
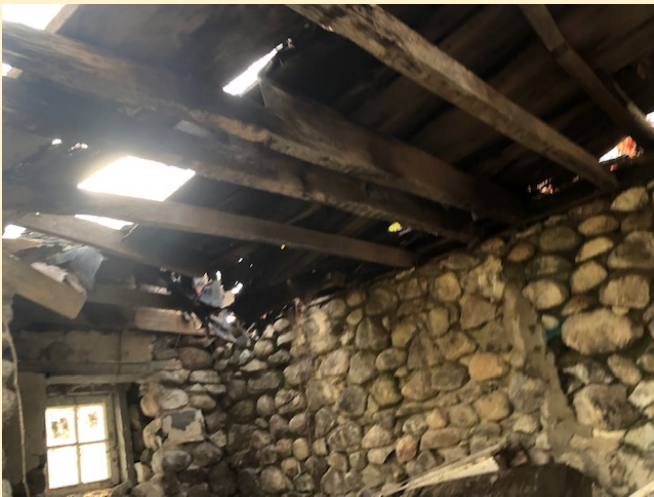
The Out House presents partial structural failure on all walls. The east wall has collapsed to the ground with missing stone material from the site and the north and south walls are still standing with structural

cracks from the footing to the roof structure supports. The west wall is apparently firm, however full access to view it was not possible.

- 1) The structure must be secured by a temporary link fence, with a permanent “No trespassing sign”.
- 2) The weeds and brush around it must be cleared from the area.
- 3) The fallen wood members and general debris must be removed from the area, to prevent the proliferation of rodents.

- 4) All structural members that are not stable, must be taken down to the ground and salvaged for future use.
- 5) The roof material would need to be disposed of after approval from the Historic District Commission.
- 6) The walls will have to be braced and secured to prevent a collapse.
- 7) All the work to be performed must be executed by a Licensed Contractor and a demolition permit must be secured before the work starts.
