Subject: Authorization for Grant Submittal – Local Bridge Program

STR 13611

BRIDGE SAFETY INSPECTION REPORT

Facility	Latitude / Longitude	MDOT Structure ID	Structure Condition
BEACH ROAD	42.581 / -83.1976	634679200079B01	Fair Condition(5)
Feature	Length / Width / Spans	Owner	
ROUGE RIVER	24 / 39.9 / 1	City: TROY(6792)	
Location	Built / Recon. / Paint / Ovly.	TSC	Operational Status
0.3 MI N OF WATTLES	1981 / / / 2012	Oakland(23)	A Open, no restriction(A)
Region / County	Material / Design	Last NBI Inspection	Scour Evaluation
Metro(7) / Oakland(63)	5 Prestressed Concrete / 05 Box Bm/Gird- Multiple	04/20/2023 / O85G	5 Stable w/in footing

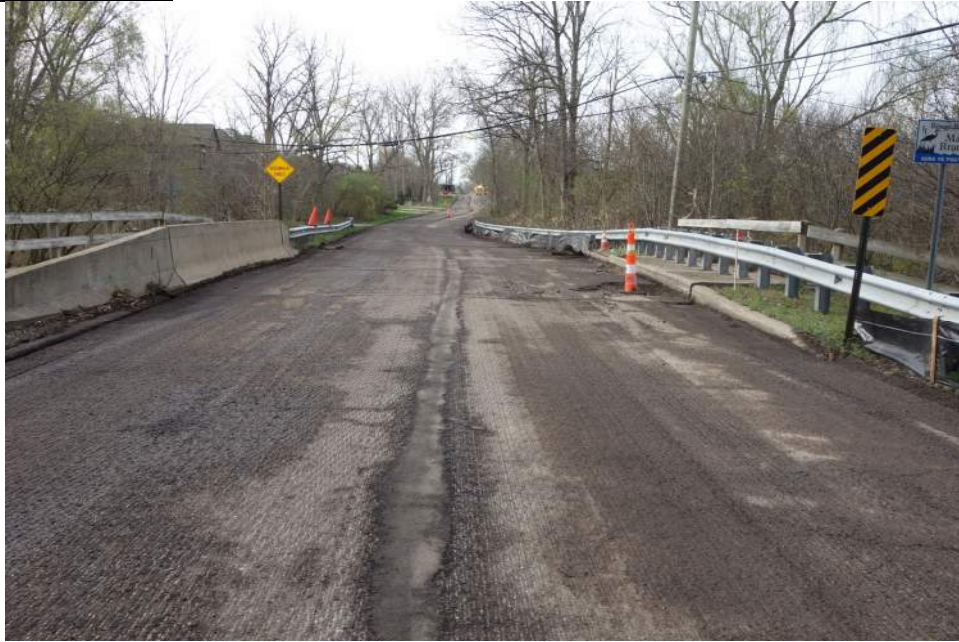
04/19	04/21	04/23	
18. Approach Pavement	7	7	7	HMA approaches milled at time of inspection. (04/23) HMA Approaches with hairline cracks. Most cracks are sealed. (04/21) HMA Approaches with hairline cracks. Most cracks are sealed (04/19)

Typical Approach

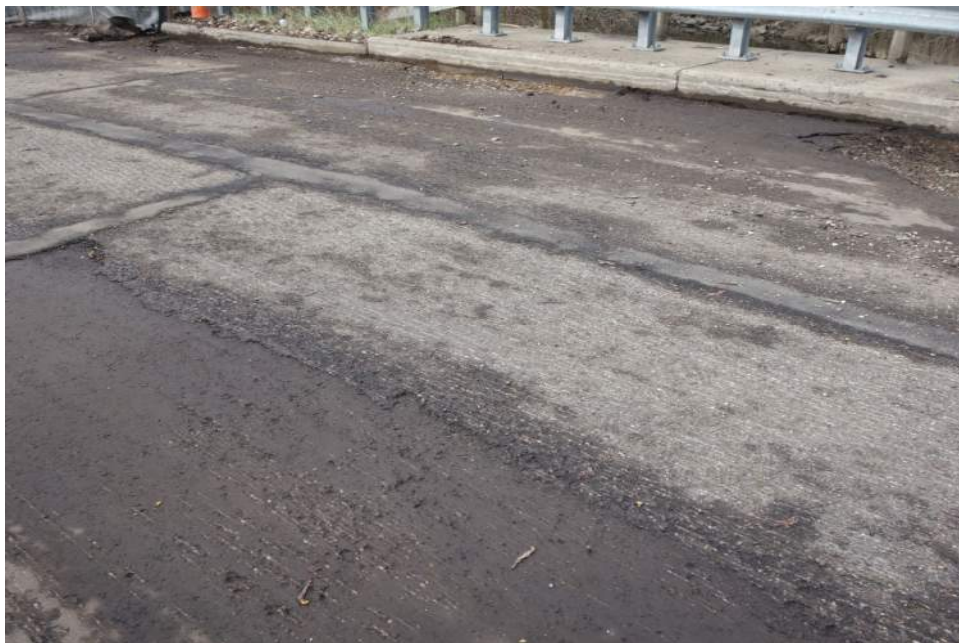
04/19	04/21	04/23	
1. Surface (SIA-58A)	6	6	6	Transverse crack at both the north and south abutments. Cracks partially sealed. Longitudinal crack at centerline at cold joint partially sealed with 2'x1' pothole at midspan filled with cold patch. Spider web cracking in northwest quadrant mostly unsealed. Some random cracking at isolated locations. HMA surface milled at time of 2023 inspection. Potholes appear to be from deck deterioration. See deck comments for more detail. (EDIT 8-31-23 - see general comments on repairs made after inspection, surface repaved after repairs) (04/23) Transverse crack at both the north and south abutments. Cracks partially sealed. Longitudinal crack at centerline at cold joint partially sealed with 2'x1' pothole at midspan filled with cold patch. Spider web cracking in northwest quadrant mostly unsealed. Some random cracking at isolated locations. (04/21) Transverse crack at both the north and south abutments. Cracks sealed. Longitudinal crack at centerline at cold joint partially sealed with 2'x1' pothole at midspan. Spider web cracking in northwest quadrant mostly unsealed (04/19)

Typical Surface

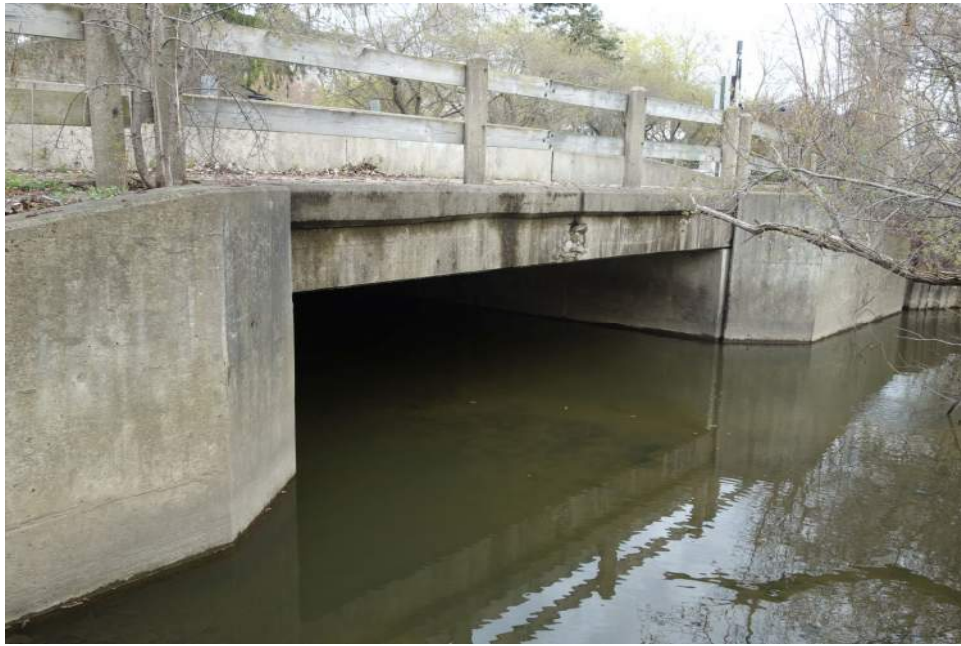
Typical Elevation

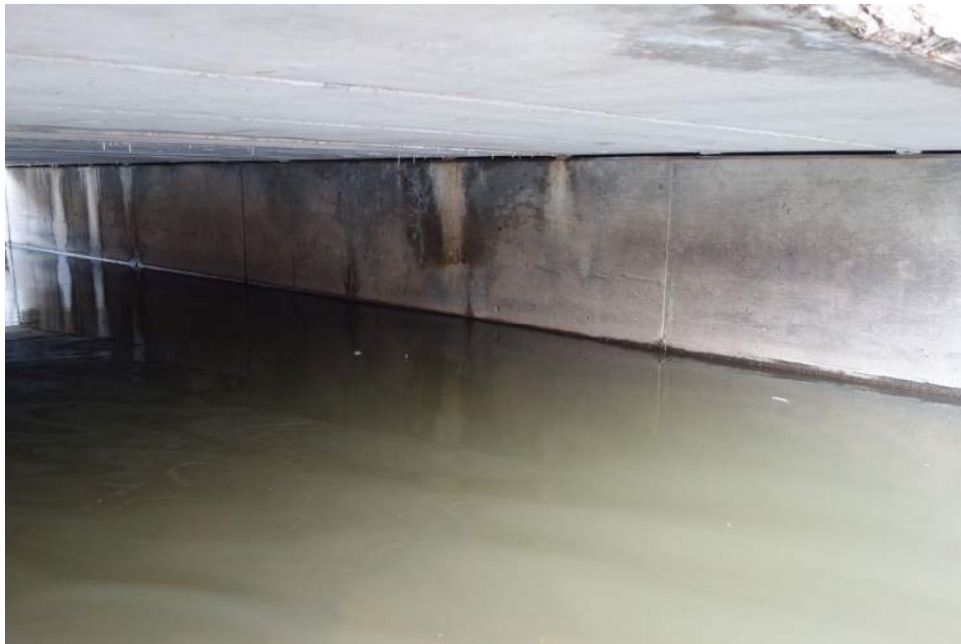
13. Abutments (SIA-60)	7	7	7	<p>Some leaching stains from leakage from backwall. A few minor hairline cracks. Separate ~2" at all abutment/wingwall interfaces and no joint sealer in place. Tree growing between abutment and wingwall on SW quadrant trimmed but not removed. Cracking south abutment beam 7W bearing area. (04/23)</p> <p>Some leaching stains from leakage from backwall. A few minor hairline cracks. Separate ~2" at all abutment/wingwall interfaces and no joint sealer in place. Tree growing between abutment and wingwall on SW quadrant trimmed but not removed. (04/21)</p> <p>Some leaching stains from leakage from backwall. Area was dry at the time of inspections. A few minor hairline cracks. Separate ~2" at all abutment/wingwall interfaces and no joint sealer in place. Tree growing between abutment and wingwall on SW quadrant trimmed but not removed. (04/19)</p>
-----------------------------------	---	---	---	---

Typical Abutment

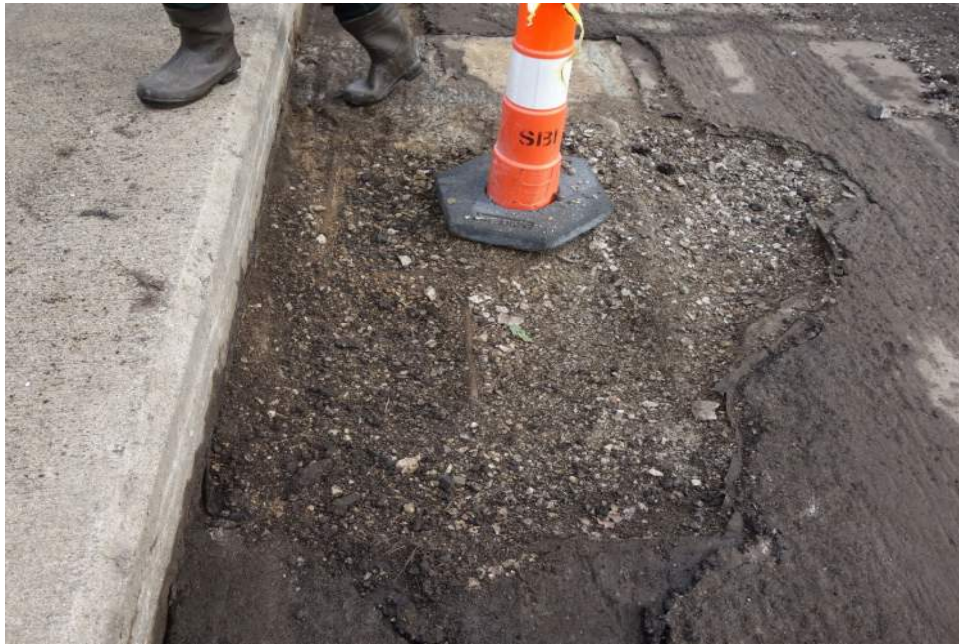
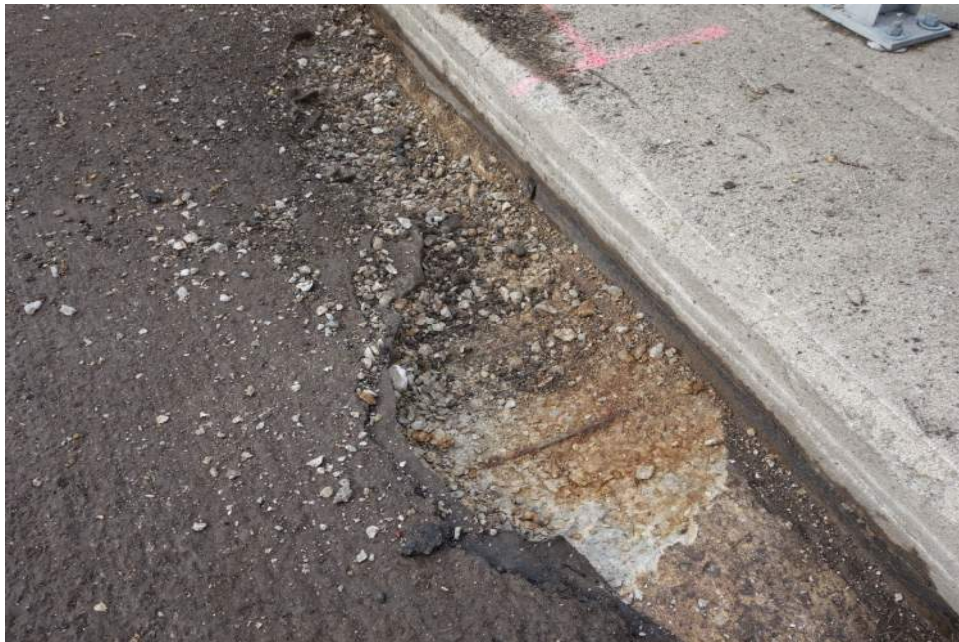
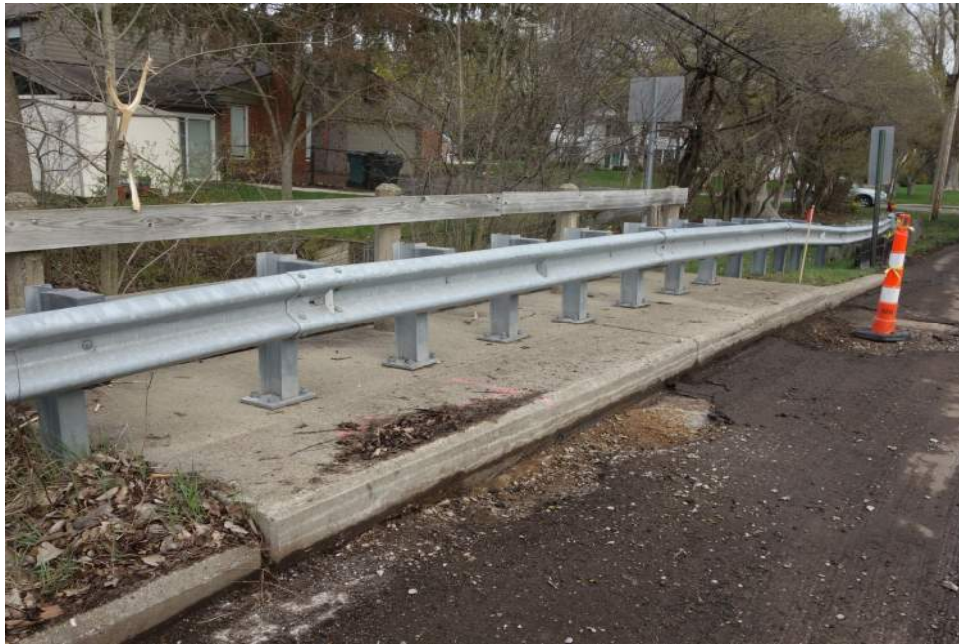
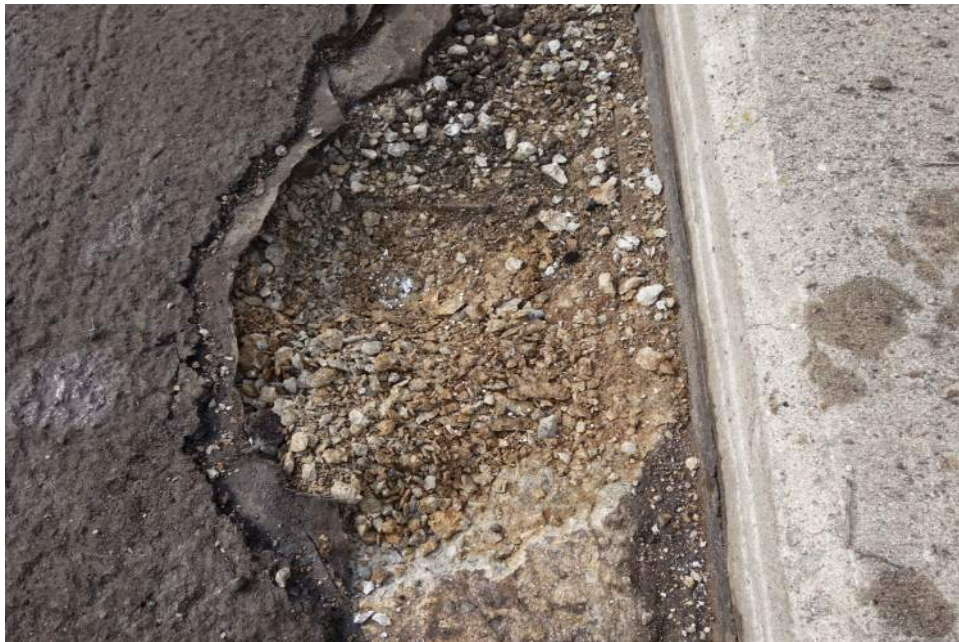
Repairs made to top of beams during road construction project in spring 2023 while road was closed. Approximately 75% of the top flanges were repaired. repairs included chipping deteriorated concrete and re-casting the top flanges of the adjacent box beams. Roadway was repaved after beam repairs. Recommend applying for superstructure replacement at next call for projects.

7. Deck (SIA-58)	6	6	5	<p>Surface in fair condition and stringers in fair condition. No deck on side-by-side box beams see surface and stringer comments. Large spalls in top of beams at midspan of west curbline and at north reference line. Rebar exposed in tops of beams 3 & 4 west. (EDIT 8-31-23 - see general comments on repairs made after inspection, surface repaved after repairs. Deck rating remains at fair due to beam condition at the time of inspection and construction) (04/23)</p> <p>Surface in fair condition and stringers in fair condition. No deck on side-by-side box beams see surface and superstructure comments. (04/21)</p> <p>Surface in fair condition and stringers in good condition. No deck on side-by-side box beams see surface and superstructure comments. (04/19)</p>
-----------------------------	---	---	---	---

Top Flange of Box Beam Deterioration

The structure is an adjacent prestressed concrete box beam structure with 1 24' span. The bridge is overall in fair condition and rated a 5. During a road rehabilitation in 2023 where the HMA surface was replaced, it was found that 75% of the top flanges of the beams had deteriorated and crumbled away. The unsound concrete was removed and recast. However, this is considered a temporary fix and only providing cover to the existing rebar in the beams. Additionally, beam 7W has a delamination $\frac{3}{4}$ of the length along the north end that is 1' wide. Beams 5W and 7W have 2 broken strands at delaminated areas. There is no structural deck, and the surface is newly paved HMA. The abutments are in good condition and rated a 7. There are small hairline cracks, cracking at south abutment beam 7W bearing area, some leaching stains, and a 2" gap between all abutment and wingwall interfaces with no joint sealer.

Recommendation Type	Priority	Description
Super Repl.	M	Superstructure deteriorating. Replacement in the next few years recommended.

The recommended repair for the bridge is a superstructure replacement. The condition of the box beams warrants replacement due to the broken strands and deteriorated top flanges of the beams. Broken strands compromise the structural integrity and load carrying capacity of the beams. The deteriorated top flange of the beams has a temporary concrete patch with an unknown service life. The only way to repair the structure is to replace the beams. The substructure is in good condition, so a full replacement is not needed. The approaches should be replaced as well to provide a smooth transition to the

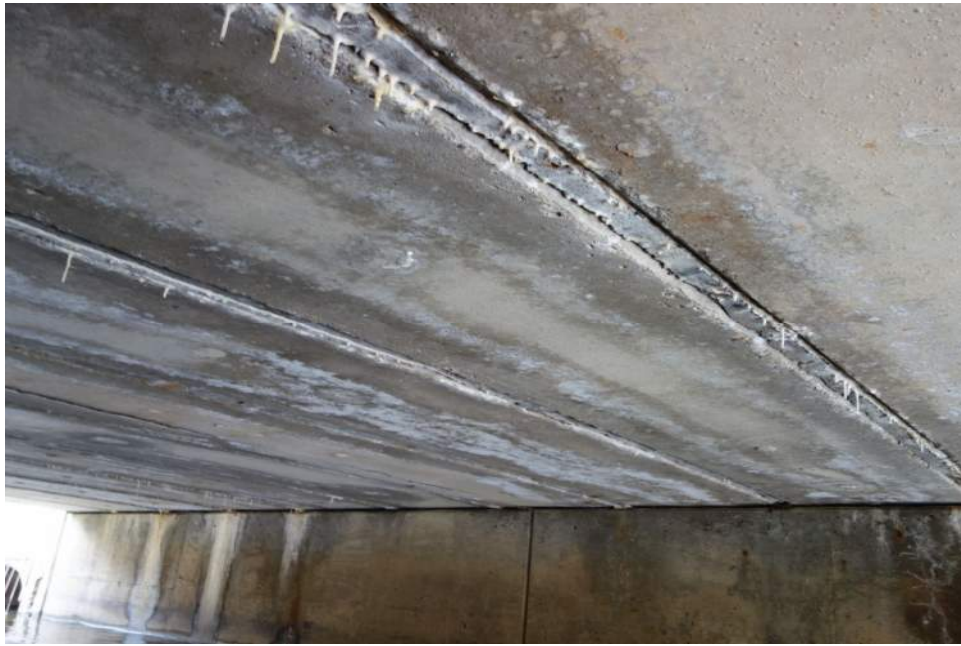
9. Stringer (SIA-59)	6	6	5	<p>13 adjacent box beams. Evidence of previous drainage from box weep holes and from between boxes. East fascia post tensioning duct grout pocket is spalled and has vegetation growing from it. Beam 7W has delamination 3/4 length along the north end 1' wide. Beam 5W middle half delaminated 1' wide. Beams 5W & 7W have 2 broken strands at delamination areas. Leaking with stalactites at most joints. For details on top of beams see deck comments. (EDIT 8-31-23 - see general comments on repairs made after inspection. No change to bottom flange condition) (04/23)</p> <p>13 adjacent box beams. Evidence of previous drainage from box weep holes and from between boxes. Fascia post tensioning duct grout pocket is spalled and has vegetation growing from it. Beam 7W has delamination 5' long by 1' wide at mid span of joint 6W and delamination at north end. Beam 5W middle third delaminated 1' wide. Leaking with stalactites at most joints (04/21)</p> <p>Evidence of previous drainage from box weep holes and from between boxes. North fascia post tensioning duct grout pocket is spalled and has vegetation growing from it. Beam 7W has delamination 5' long by 1' wide at mid span of joint 6W and delamination at north end. Beam 5W middle third delaminated 1' wide. Leaking with stalactites at most joints (04/19)</p>

Typical Leaching Joint Between Box Beams

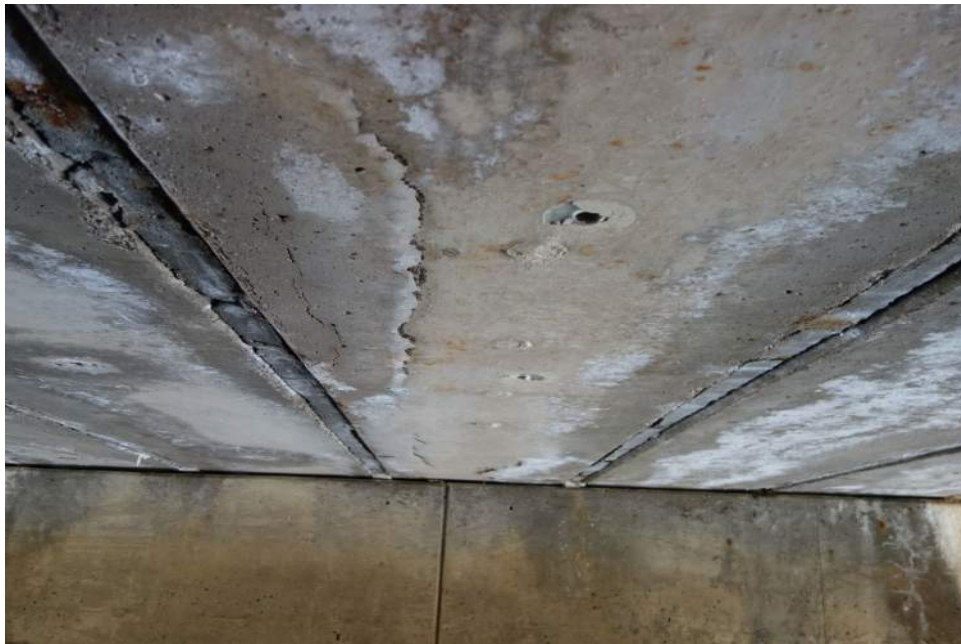
Beam 5W Cracking

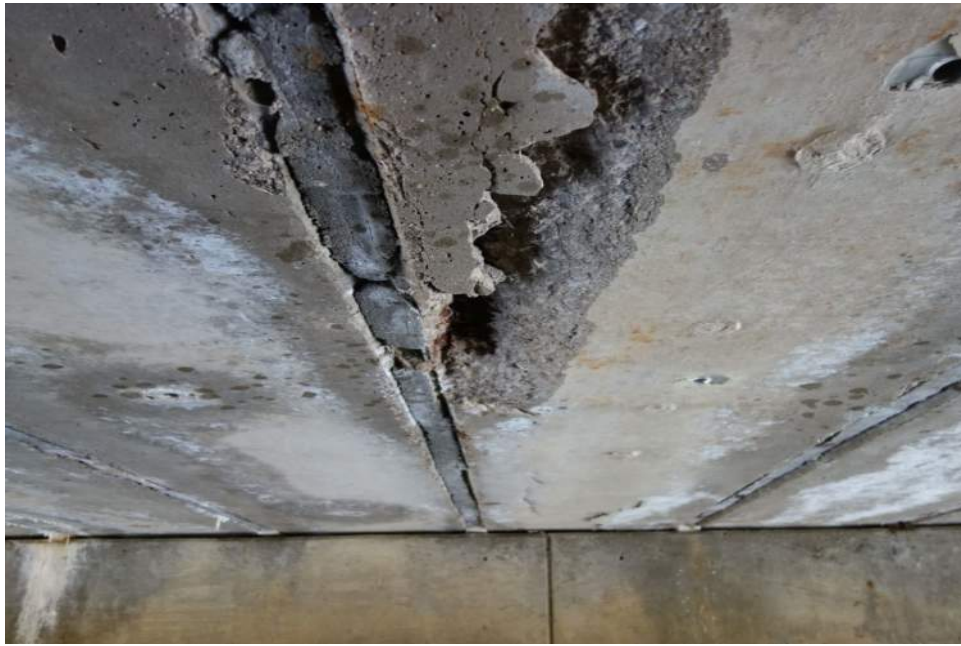
Beam 7W Delamination and Broken Strand
