# **CITY COUNCIL AGENDA ITEM**

RE: Proposal for Professional Services Troy Historic Village – Wagon Shop

## Troy Historic Village Wagon Shop Structural Assessment

60 West Wattles Road, Troy, MI 48098 WJE No. 2021.5313

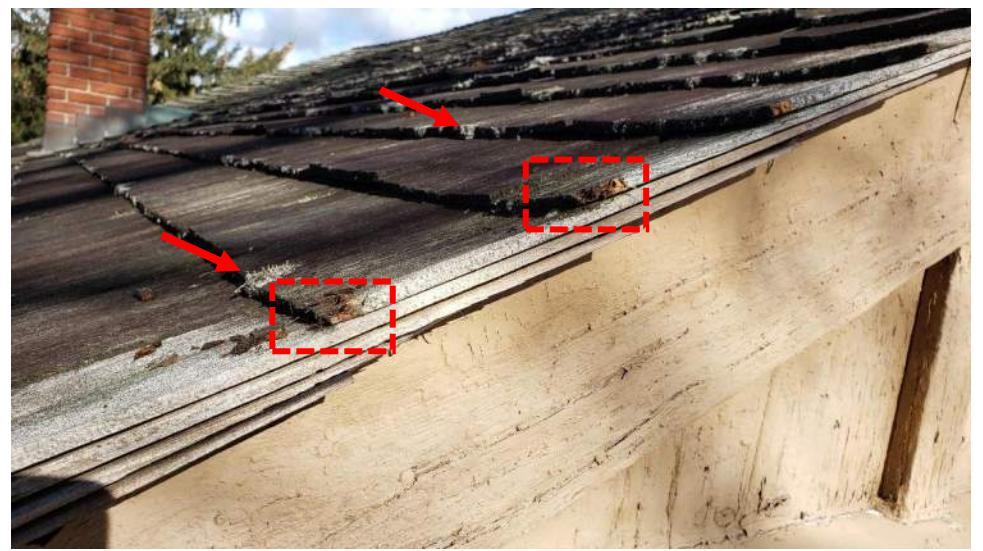
- 1. Multiple cedar shingles are damaged or missing. Vegetation growth is present on the roof shingles, and localized areas of decay is common along the edges of the shingles (Figure 2).
- 2. The roof ridge is visually displaced downward, with the south half of the roof exhibiting greater displacement than the north (Figure 3). Additionally, the rafters are deflected downward along their span most noticeably on the south half of the roof.
- 3. Localized char is present on multiple roof framing members, primarily within the south half of the building, though the center beam and perimeter top plates and headers also exhibit localized char (Figure 4). The measured char depth typically measures 1/16-inch, but extends up to 1/8-inch. Soot staining, but no char, is also present at some of the roof framing members.

Figure 2. Localized decay (boxed areas) and lichen growth (arrows) on the roof shingles.

- 6. Reinforce the fractured loft joist by means of attaching dimensional lumber on one side of the joist for the full span of the joist.
- 7. Replace the deteriorated portions of the exterior battens and trim along the walls.

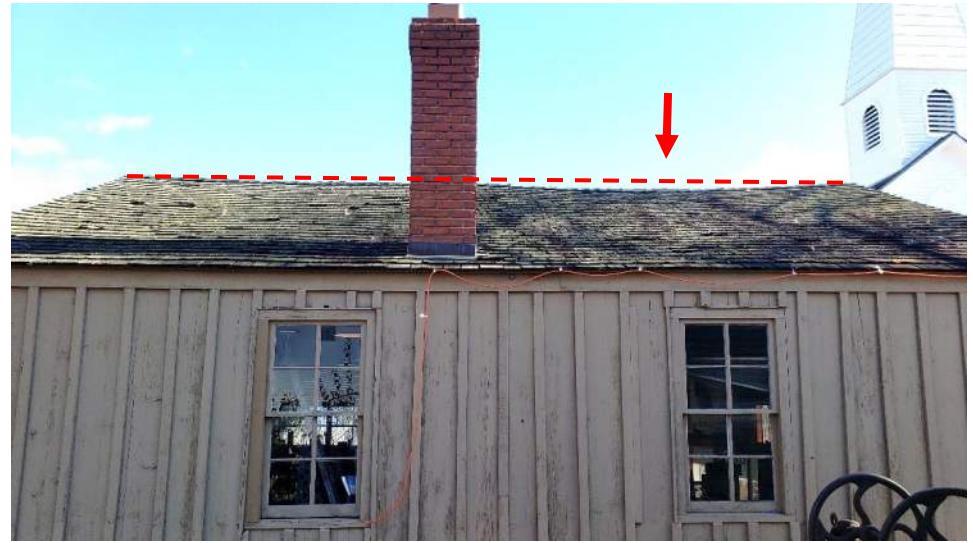
Figure 3. Visible deflection of the roof viewed from the west side of the building.

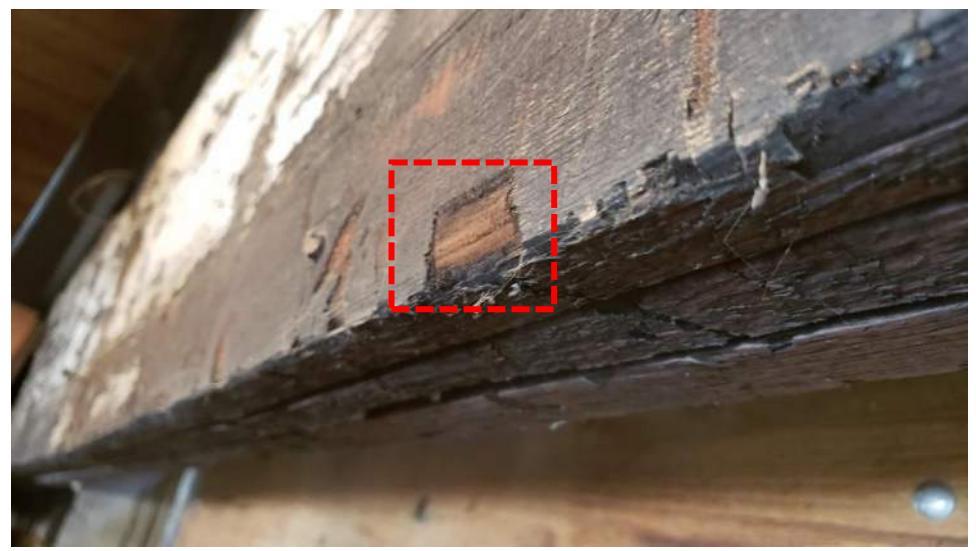
Figure 4. Char on the north wall header. The box indicated a location where char was removed.

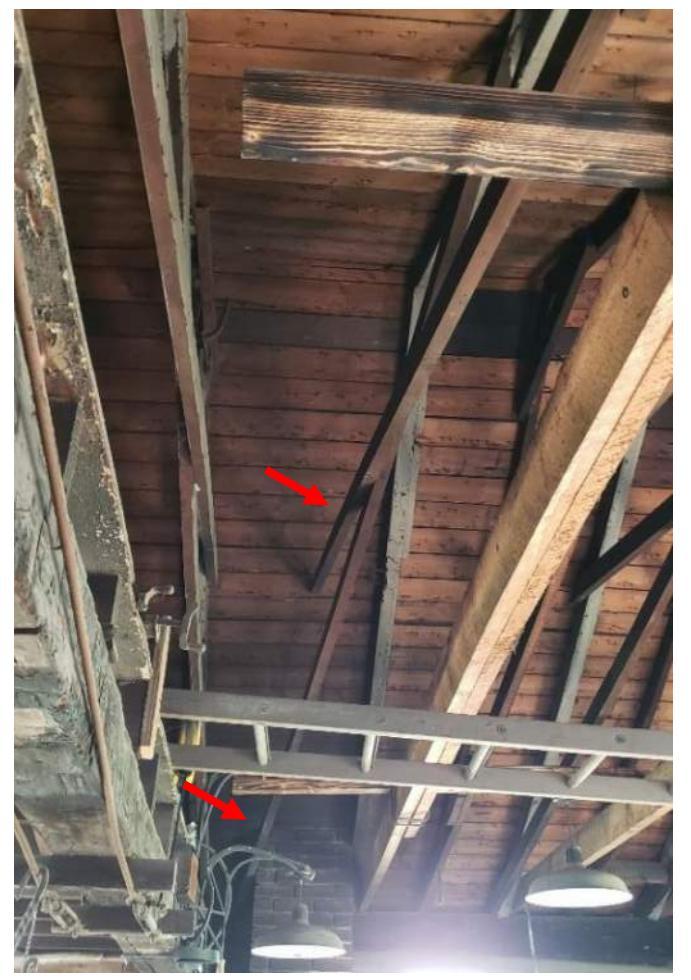
- i. At one set of rafters, both cross-bracing members are unsecured to the west rafter to accommodate the masonry chimney (Figure 6). The rafter is also notched to accommodate the chimney (Figure 7).

Figure 6. Cross-bracing is unsecured to west rafter to accommodate chimney.

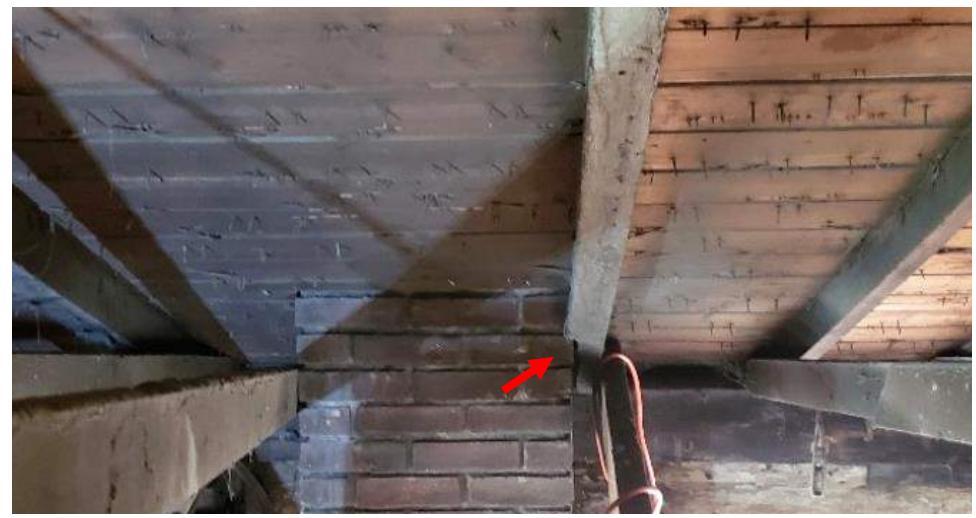
Figure 7. Notched rafter at chimney.

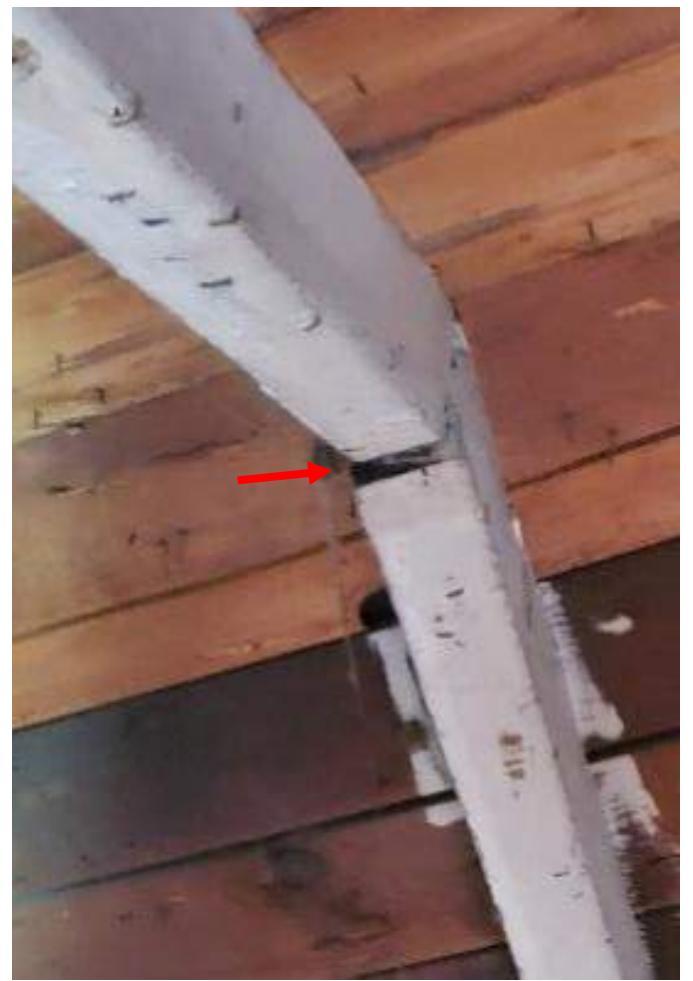
Figure 8. Unpainted end of rafters. Note paint on underside of some of the roof decking.

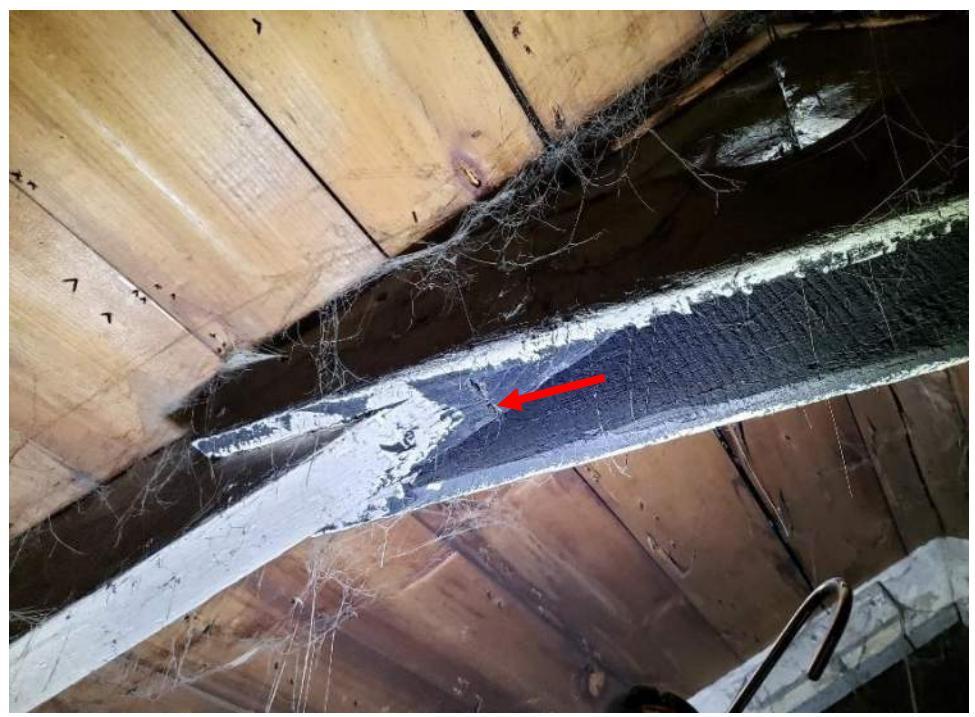
- i. A set of rafters are fractured near 1x gusset plates at the ridge. The gusset plates are unique to this set of rafters. The gusset plates and the west rafter, at the fracture location, are charred up to 1/8-inch deep (Figure 10). While the rafter is charred around the fracture, the exposed fractured surface is not charred (Figure 11).

The observed southern roof deflections, wall displacement, and fractured rafters are consistent with the calculated DCR values being greater than 1.0. Because the support of the knee walls is insufficient, the span of the south rafters is increased, resulting in overstress conditions and excessive deflection of the rafter members, especially those affected by the fire event. Additionally, the southern rafter collar ties provide minimal restraint for the lateral thrust of the rafters due to their location relative to the ridge. Without the support at the knee wall or attachment of the rafter system to the loft floor structure, the roof thrust presents itself through the outward displacement of the timber beam at the top of the walls and the downward displacement of the ridge line. The timber top plate of the west wall is actively supporting

Figure 10. Fractured rafter (arrow) near the ridge, where char is located.

- 4. Regardless of the strengthening method(s) pursued, reinforce the distressed fractured and charred rafters at the southern half of the building by means of attaching dimensional or engineered lumber to the side of the rafters for their full length.

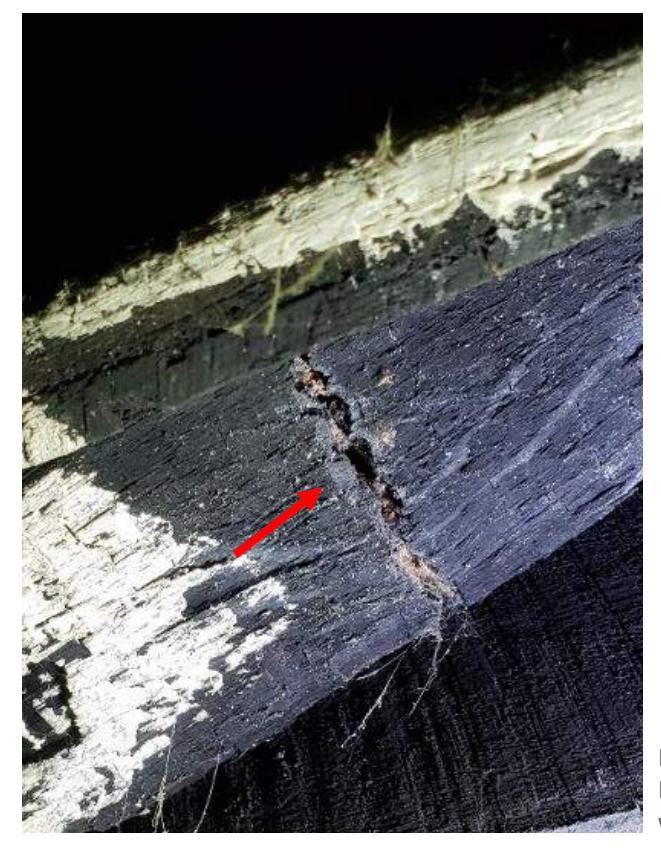
Figure 11. Up-close view of the fractured rafter shown in Figure 10. Note the absence of char and smoke staining within the fractured surface.

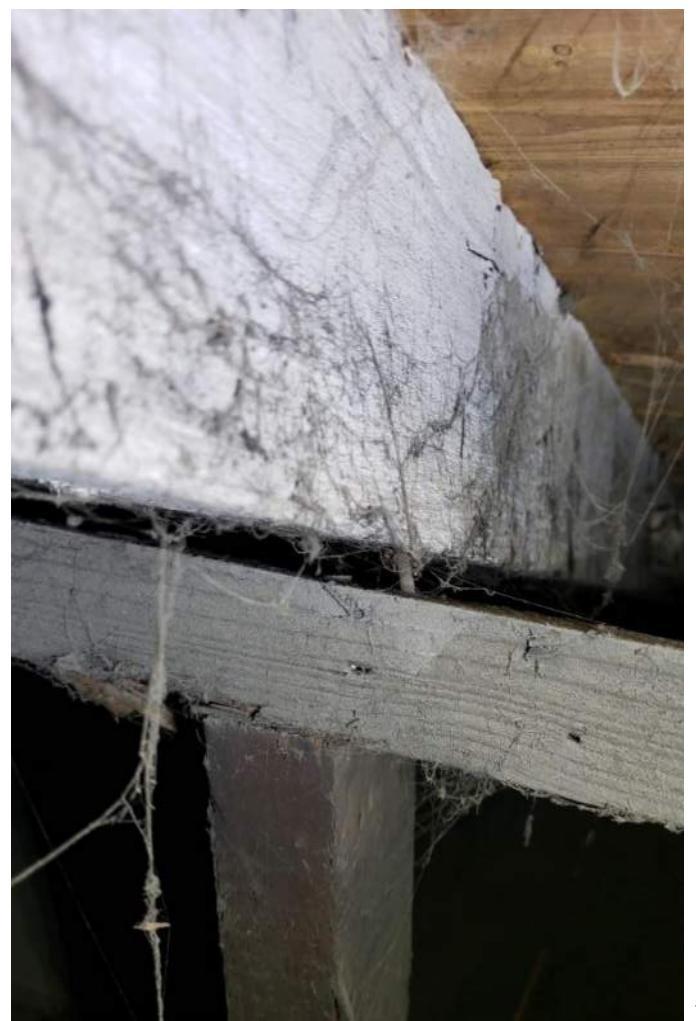
- A gap is present between most rafters and the knee wall top plate (Figure 12). A gap also commonly exists between the top plate and studs or between the studs and the bottom plate (Figure 13). The nail shanks connecting the various components are visible in the gaps.

The separation of the knee wall members between the rafters and the loft floor framing is likely related to the seasonal loading of the roof acting on the loft floor joists. Under the snow load conditions of the unheated building, the loft floor joists supporting the knee wall deflect, potentially inelastically (creep). The joists will not recover to a level condition if the deformation is inelastic, allowing the knee wall members to separate at connection points as the seasonal loading is removed and the rafters return to their undeflected condition. Additionally, the net wind uplift forces may contribute to the separation of the knee wall members. Reinforcement of the knee wall member connections to accept the uplift force at the rafter bearing locations, and either modification to the southern rafter framing system to support the demand loads, or temporary shoring of the knee wall during the winter months, is recommended.

Figure 12. Rafter not bearing directly on a knee wall top plate.

- i. Replace the missing stud member of the knee walls, reinforce the knee wall member connections to allow for the design wind uplift force, and provide hardwood shims as necessary to ensure full bearing between the rafters and the supporting loft floor joists.

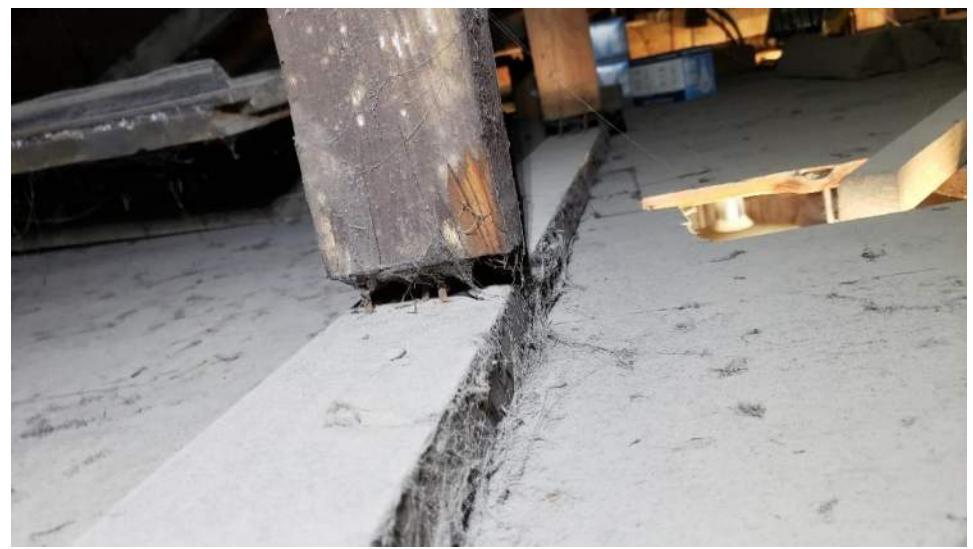
Figure 13. Knee wall stud is not bearing directly on the knee wall bottom plate.

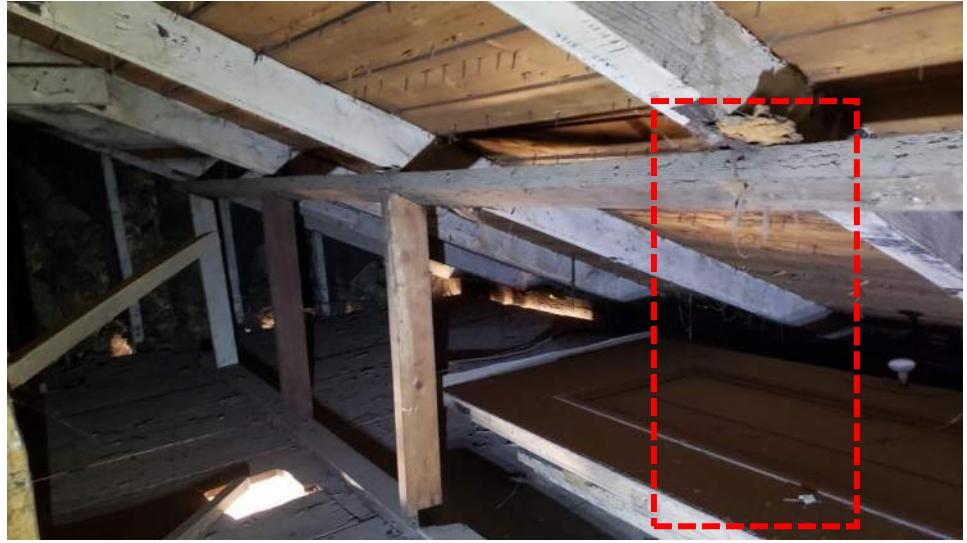
- iii. A stud is missing in the west knee wall (Figure 14).

Figure 14. Missing stud below rafter in the west knee wall.

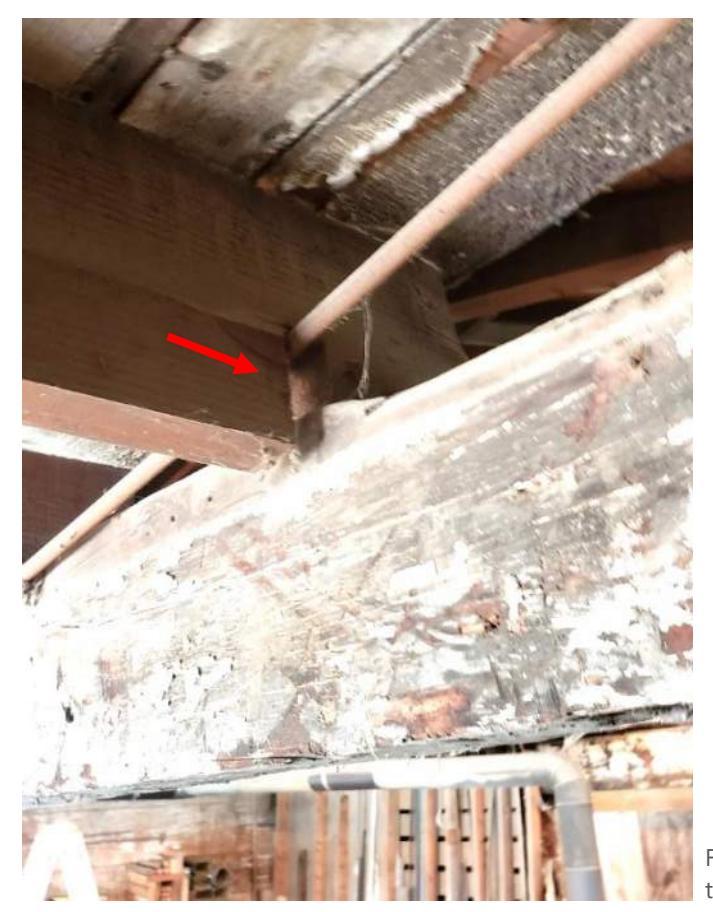
the tension rods extend above the top of the center beam. In these areas, the joists were notched up to 3-inches around the tension rods (Figure 16).

As stated in the analysis discussion above, the notch in the loft floor joists to accommodate the tension rods at the center beam will limit the capacity of the joists. However, the addition of a wood 2x ledger secured to the timber beam will alleviate the concern with the deep notches. The typical joists will then be adequate for a 20psf floor live load, but the joists supporting the knee wall above are to be reinforced, assuming there are no alterations made of the southern rafter system. The fracture through the knot of the one joist may be related to the seasonal overloading of the joists, and occurred at this joist due to the presence of the knot at the bottom edge of the member.

Figure 16. Large notch to accommodate center beam tension rod.

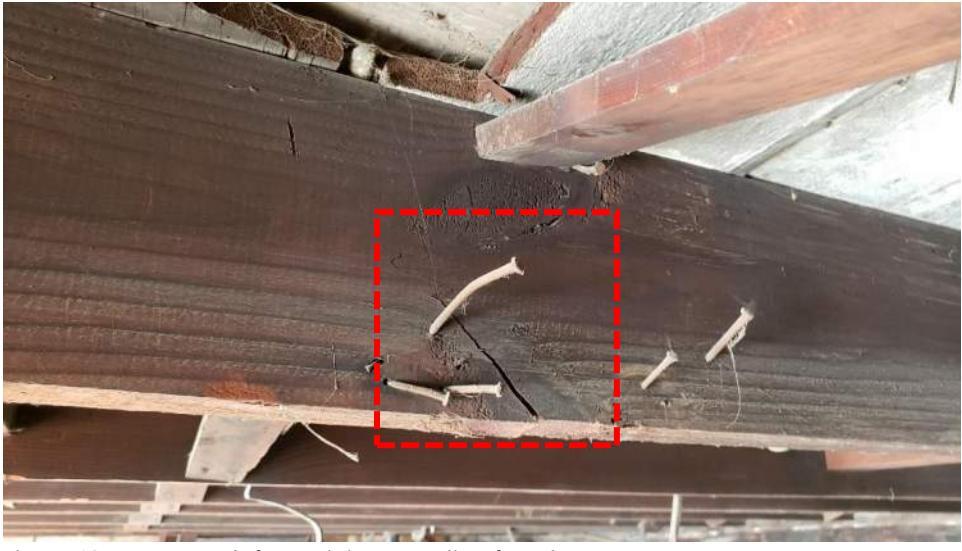
- 7. Cross-bridging is located at midspan of the loft floor joists. (Figure 17).
- 8. A partial depth fracture is located near midspan of the fifth joist as counted from the east wall. The fracture extends from a knot on the bottom edge of the wood member where the fracture is widest (Figure 18).

Figure 18. Fracture at loft area joint extending from knot.

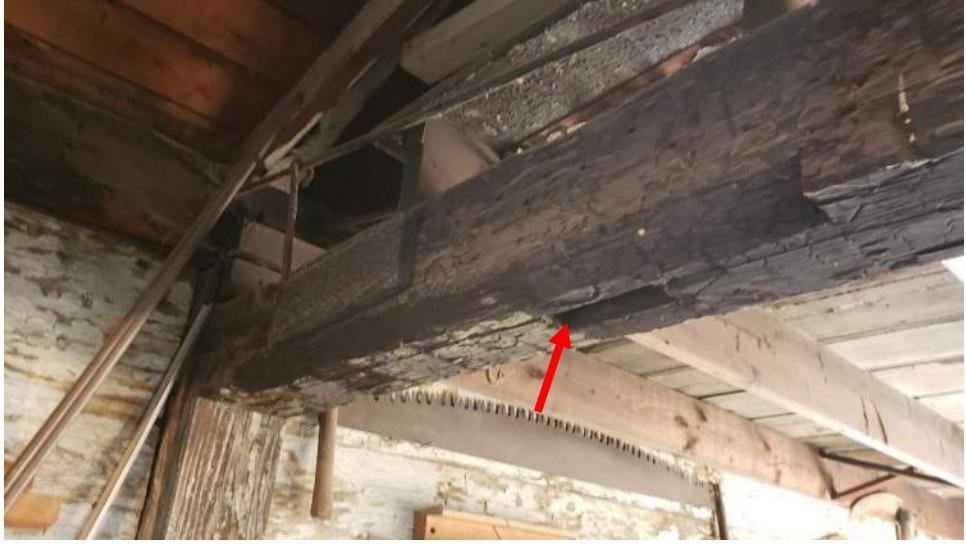
- a. The northwest tension rod is no longer in direct contact with the wood spacers located on the underside of the timber beam.
  - b. There are two abandoned mortises on the underside, one at each end of the beam, suggesting knee braces or columns were once connected to the beam (Figure 20). Additionally, a ghosting of a past column is present near midspan on the underside of the beam (Figure 21).

Figure 20. Abandoned mortise on center beam underside.

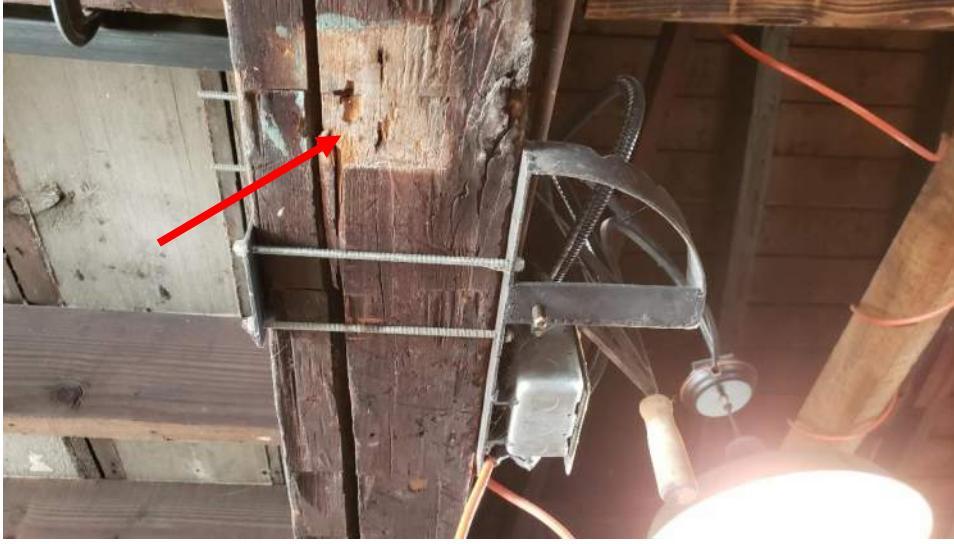
Figure 21. Shadow of likely previous column on underside of center beam.

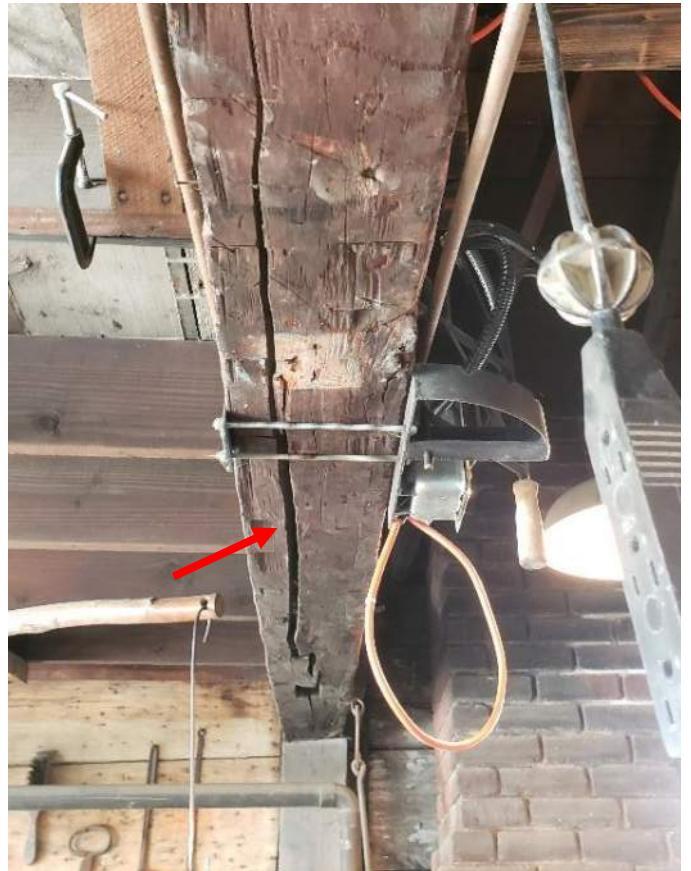
- c. Checks are present in the underside and north faces of the timber beam (Figure 22).
  - d. Surface char is present on the timber beam, intermittently along the span of the beam (Figure 23).

Figure 22. Check on center beam underside.

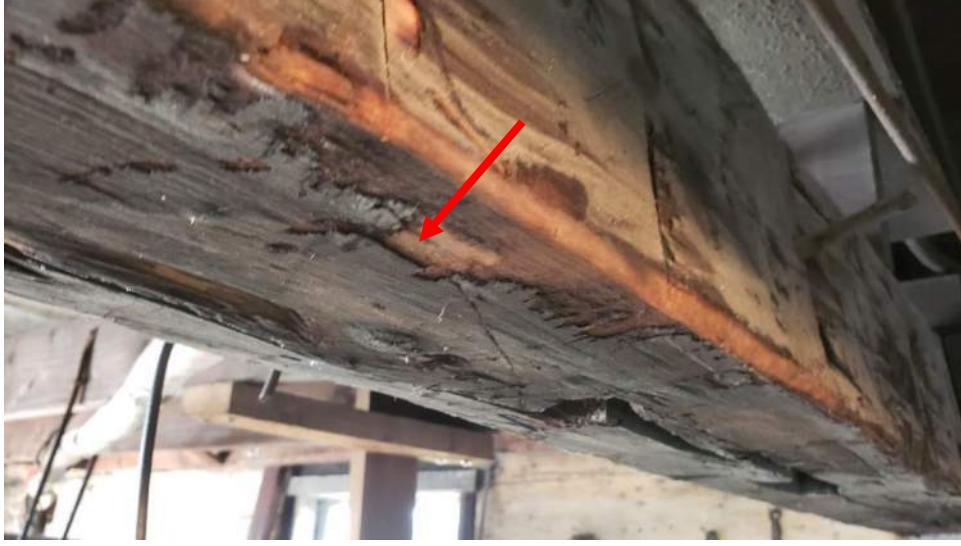
Figure 23. Surface char on center beam underside.

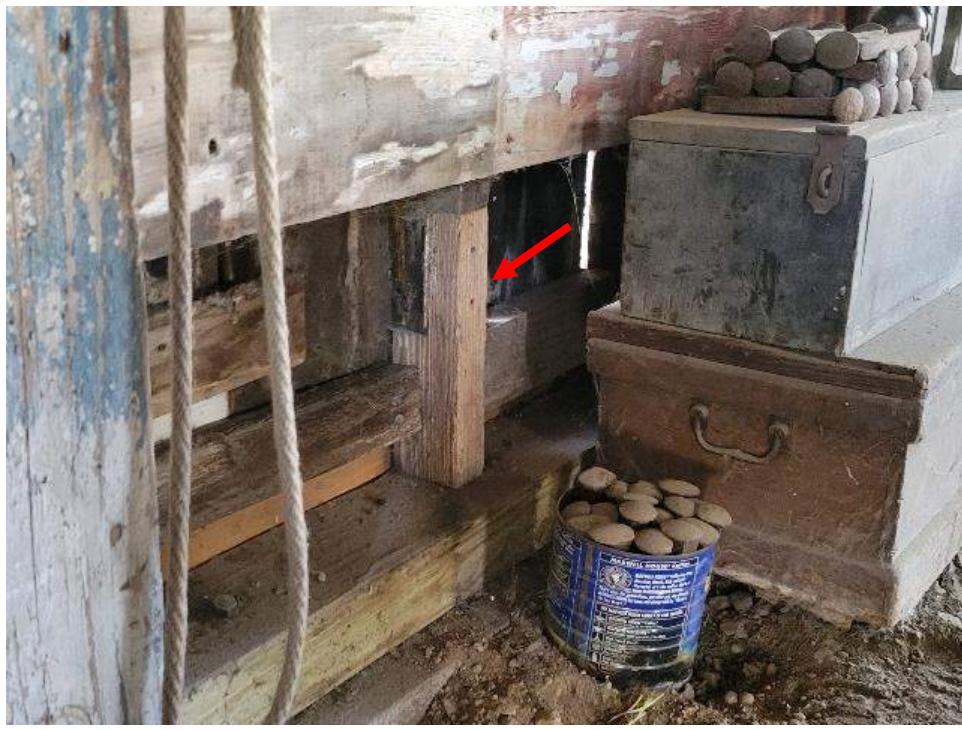
- i. In at least one location, the wood stud is spliced at the bottom, likely as a previous repair of deteriorated wood (Figure 25).
    - ii. Minor water staining is present at one exposed location at the top surface of the treated base plate.

Figure 25. Wood splice at a wall stud.

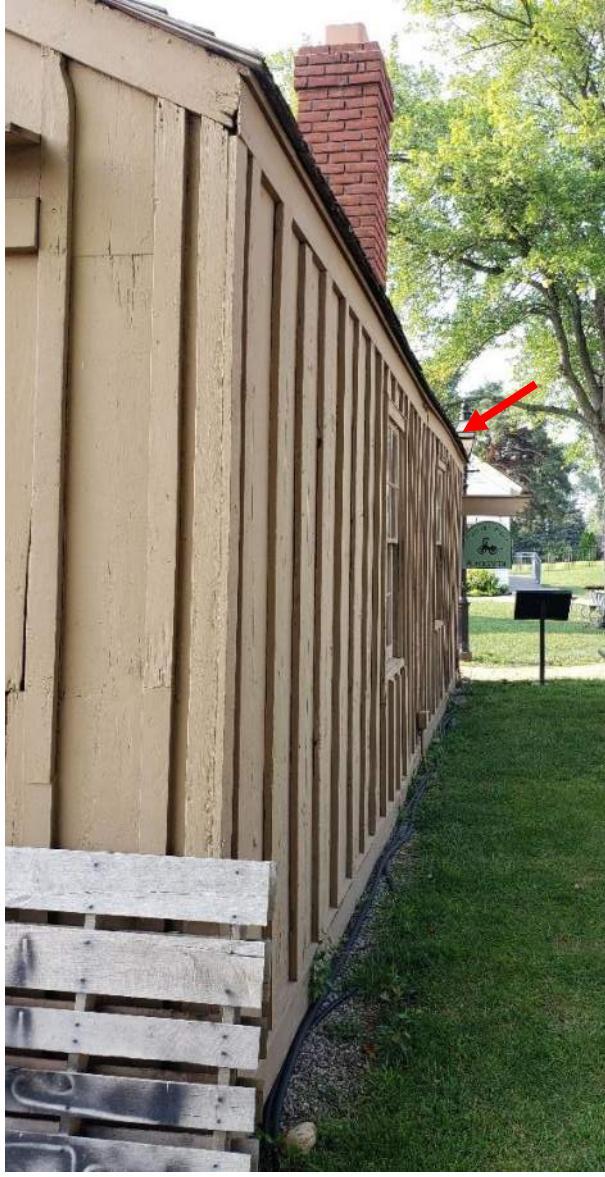
- 12. The top of the west wall is visibly, horizontally displaced outward on the south half of the building (Figure 26) up to 7/8 of an inch over the 9 foot height of the wall. At the center beam location, the wall is displaced inward 1/2 of an inch over the height of the wall. A 3/8 of an inch outward

the roof thrust, spanning between the west center and southwest corner support posts. With proper support provided, the roof thrust should be minimal, and the outward displacement of the west wall may be able to be resolved back to a near-plumbed condition.

Figure 26. West wall of the building. The arrow indicates the approximate location of maximum outward displacement.

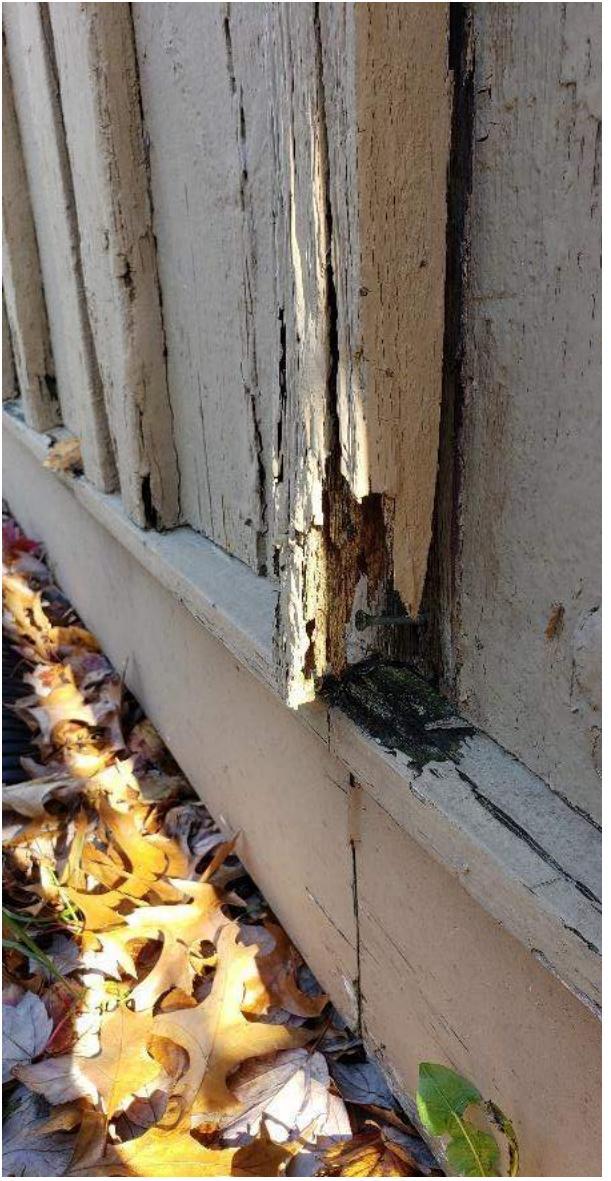
13. Localized decay is present in the exterior wood boards intermittently throughout but is more concentrated at the bottom of the battens (Figure 27).

Figure 27. Decay at the bottom of batten and horizontal trim board.
