CITY COUNCIL AGENDA ITEM

Subject: Authorization for Grant Submittal – Local Bridge Program

STR 13611

BRIDGE SAFETY INSPECTION REPORT

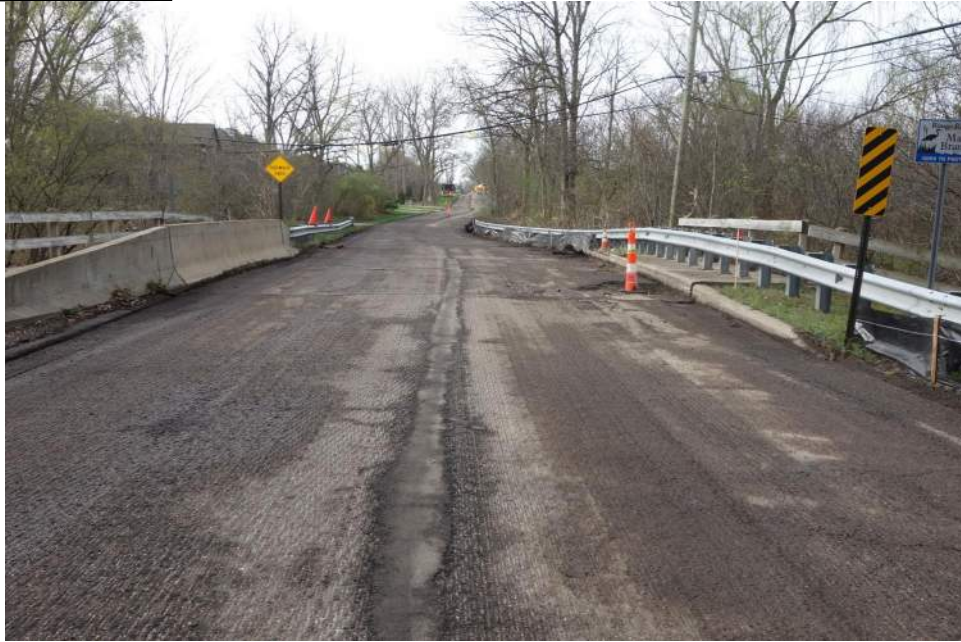
Typical Approach

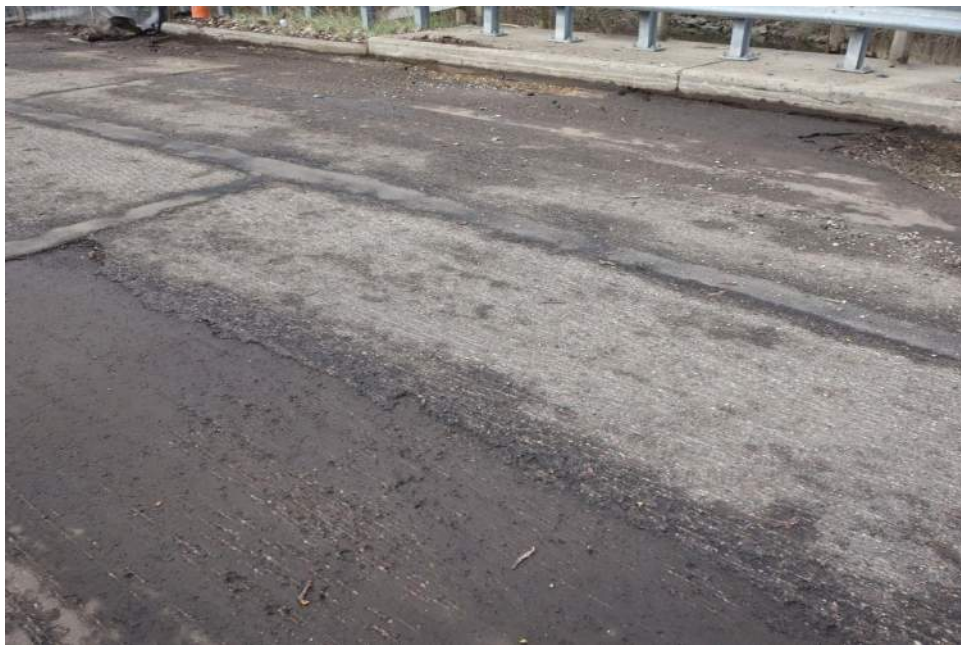
Typical Surface

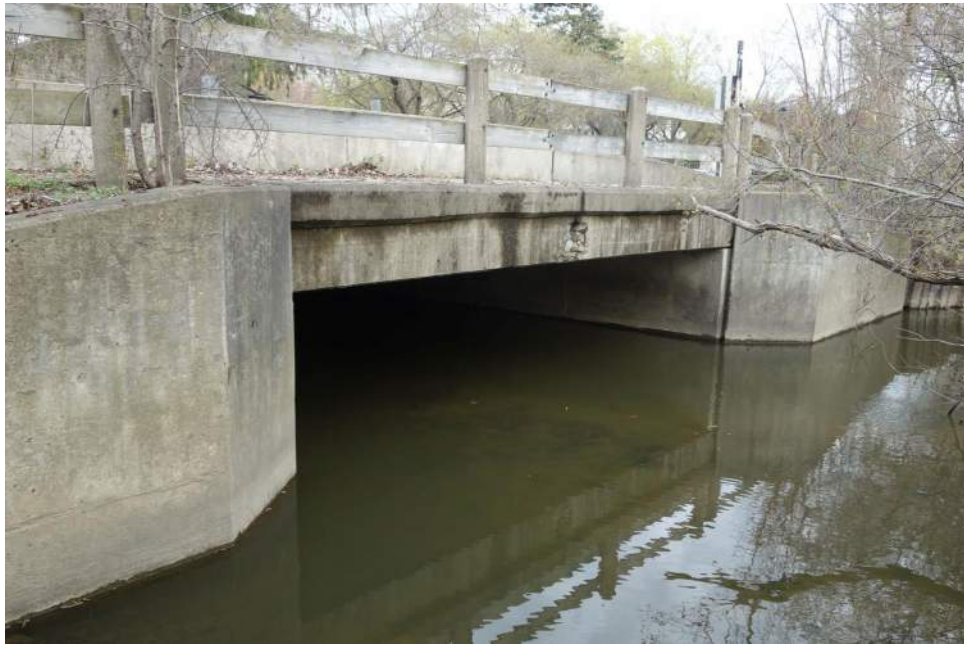
Typical Elevation

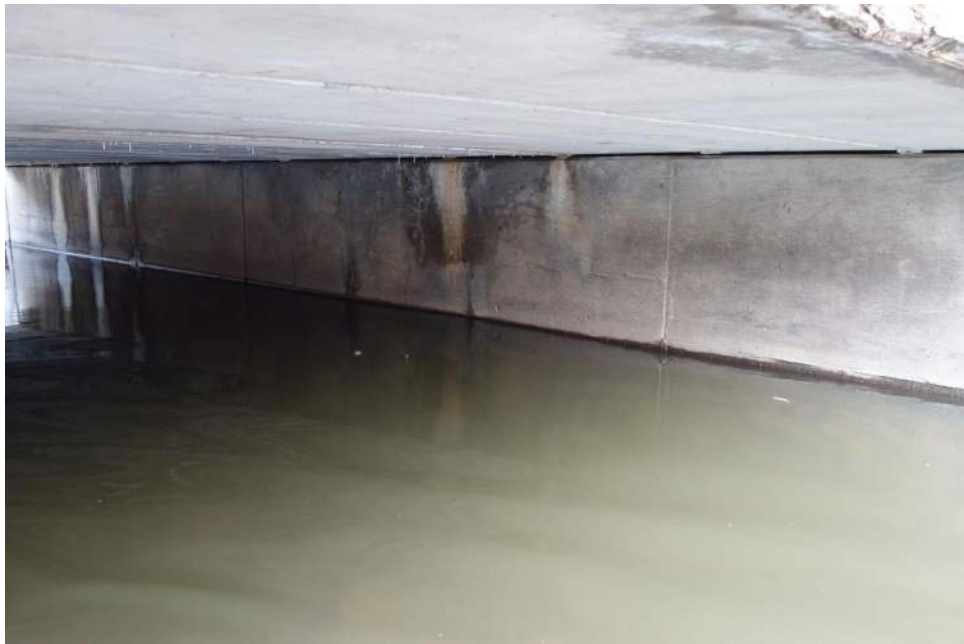
04/19	04/21	04/23	
13. Abutments (SIA-60)	7	7	7	Some leaching stains from leakage from backwall. A few minor hairline cracks. Separate ~2" at all abutment/wingwall interfaces and no joint sealer in place. Tree growing between abutment and wingwall on SW quadrant trimmed but not removed. Cracking south abutment beam 7W bearing area. (04/23) Some leaching stains from leakage from backwall. A few minor hairline cracks. Separate ~2" at all abutment/wingwall interfaces and no joint sealer in place. Tree growing between abutment and wingwall on SW quadrant trimmed but not removed. (04/21) Some leaching stains from leakage from backwall. Area was dry at the time of inspections. A few minor hairline cracks. Separate ~2" at all abutment/wingwall interfaces and no joint sealer in place. Tree growing between abutment and wingwall on SW quadrant trimmed but not removed. (04/19)

Typical Abutment

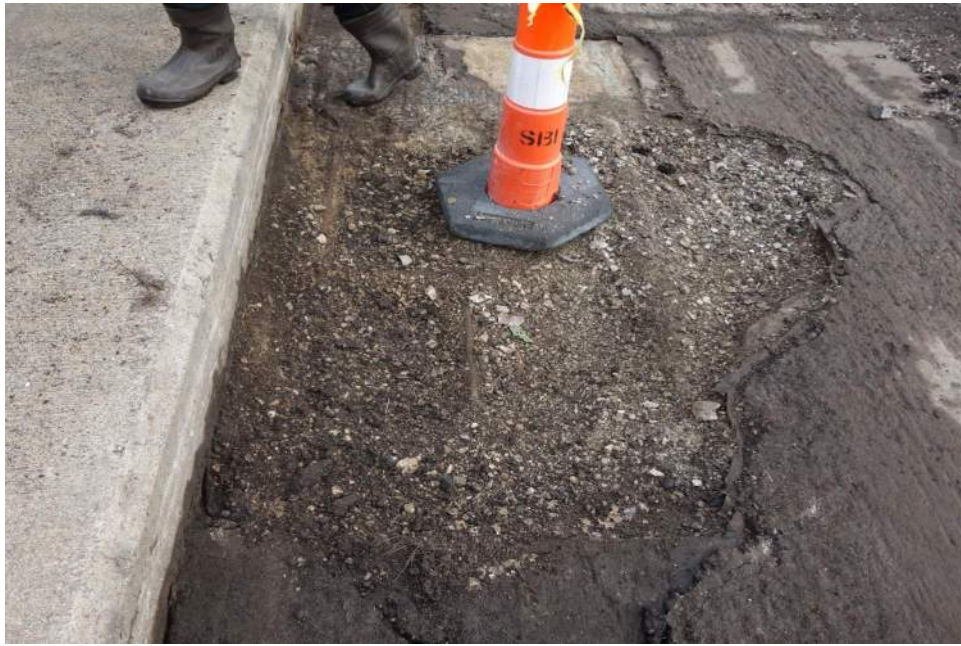
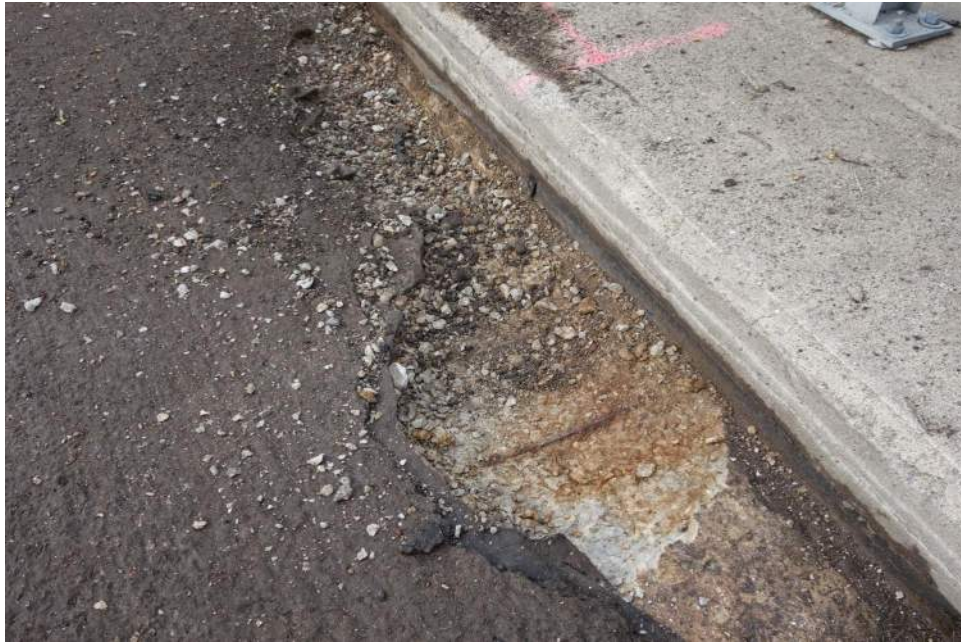
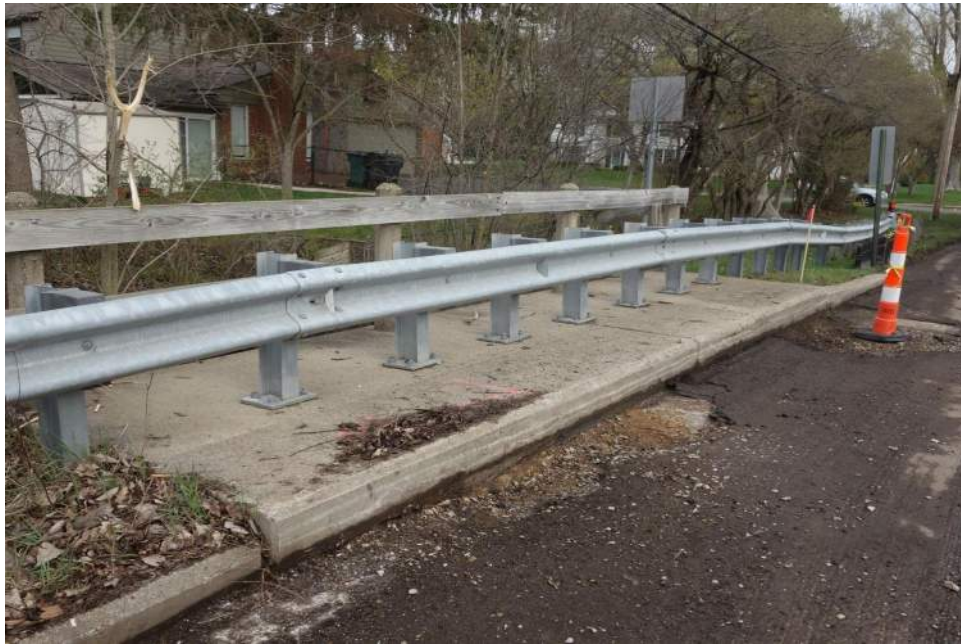
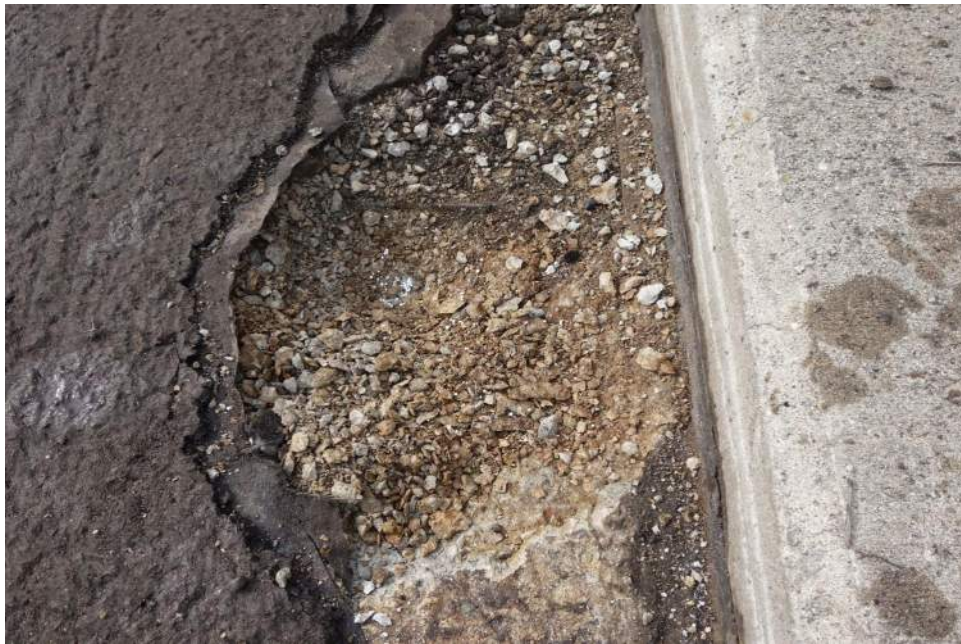
Repairs made to top of beams during road construction project in spring 2023 while road was closed. Approximately 75% of the top flanges were repaired. repairs included chipping deteriorated concrete and re-casting the top flanges of the adjacent box beams. Roadway was repaved after beam repairs. Recommend applying for superstructure replacement at next call for projects.

Top Flange of Box Beam Deterioration

The structure is an adjacent prestressed concrete box beam structure with 1 24' span. The bridge is overall in fair condition and rated a 5. During a road rehabilitation in 2023 where the HMA surface was replaced, it was found that 75% of the top flanges of the beams had deteriorated and crumbled away. The unsound concrete was removed and recast. However, this is considered a temporary fix, and only providing cover to the existing rebar in the beams. Additionally, beam 7W has a delamination $\frac{3}{4}$ of the length along the north end that is 1' wide. Beams 5W and 7W have 2 broken strands at delamination areas. There is no structural deck and the surface is newly paved HMA. The abutments are in good condition and rated a 7. There are small hairline cracks, cracking at south abutment beam 7W bearing area, some leaching stains, and a 2" gap between all abutment and wingwall interfaces with no joint sealer.

Recommendation Type	Priority	Description
Super Repl.	M	Superstructure deteriorating. Replacement in the next few years recommended.

The recommended repair for the bridge is a superstructure replacement. The condition of the box beams warrants replacement due to the broken strands and deteriorated top flanges of the beams. Broken strands compromise the structural integrity and load carrying capacity of the beams. The deteriorated top flange of the beams has a temporary concrete patch with an unknown service life. The only way to repair the structure is to replace the beams. The substructure is in fair condition and rehabilitated, so a full replacement is not needed. The approaches should be replaced as well to provide a smooth

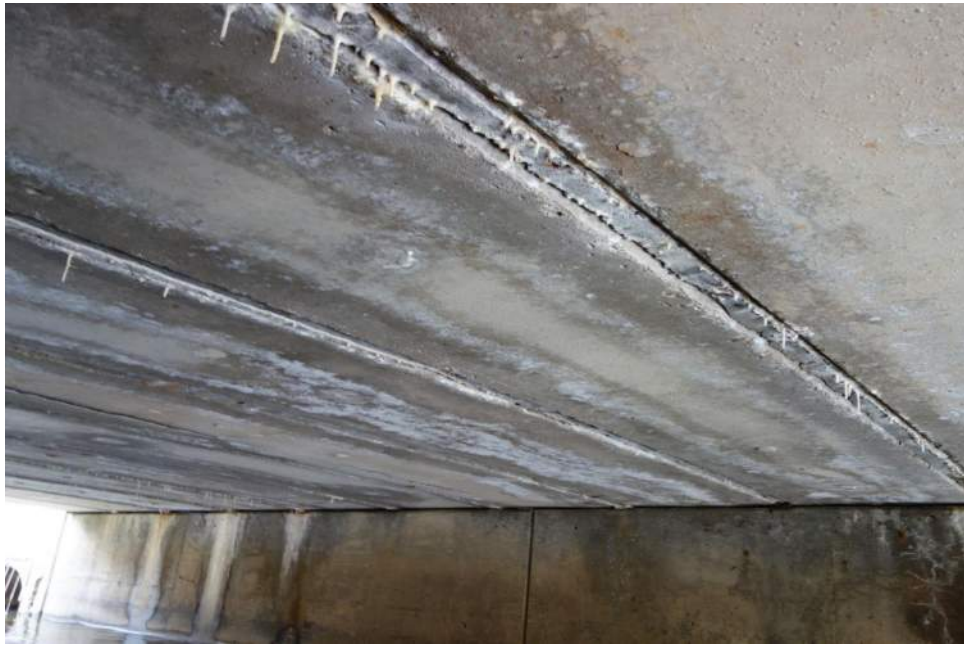
04/19	04/21	04/23	
9. Stringer (SIA-59)	6	6	5	13 adjacent box beams. Evidence of previous drainage from box weep holes and from between boxes. East fascia post tensioning duct grout pocket is spalled and has vegetation growing from it. Beam 7W has delamination 3/4 length along the north end 1' wide. Beam 5W middle half delaminated 1' wide. Beams 5W & 7W have 2 broken strands at delamination areas. Leaking with stalactites at most joints. For details on top of beams see deck comments. (EDIT 8-31-23 - see general comments on repairs made after inspection. No change to bottom flange condition) (04/23) 13 adjacent box beams. Evidence of previous drainage from box weep holes and from between boxes. Fascia post tensioning duct grout pocket is spalled and has vegetation growing from it. Beam 7W has delamination 5' long by 1' wide at mid span of joint 6W and delamination at north end. Beam 5W middle third delaminated 1' wide. Leaking with stalactites at most joints (04/21) Evidence of previous drainage from box weep holes and from between boxes. North fascia post tensioning duct grout pocket is spalled and has vegetation growing from it. Beam 7W has delamination 5' long by 1' wide at mid span of joint 6W and delamination at north end. Beam 5W middle third delaminated 1' wide. Leaking with stalactites at most joints (04/19)

Typical Leaching Joint Between Box Beams

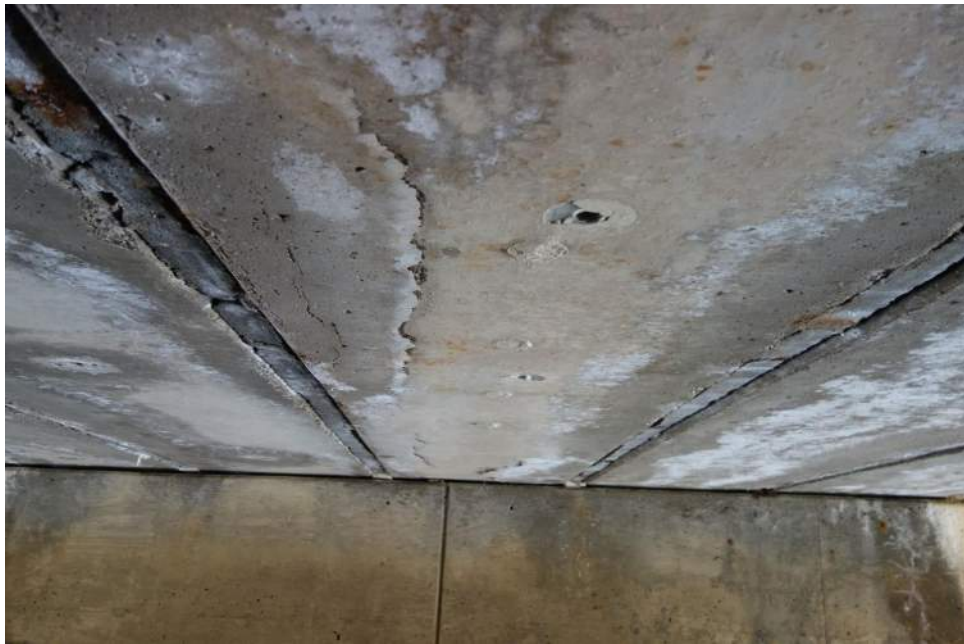
Beam 5W Cracking

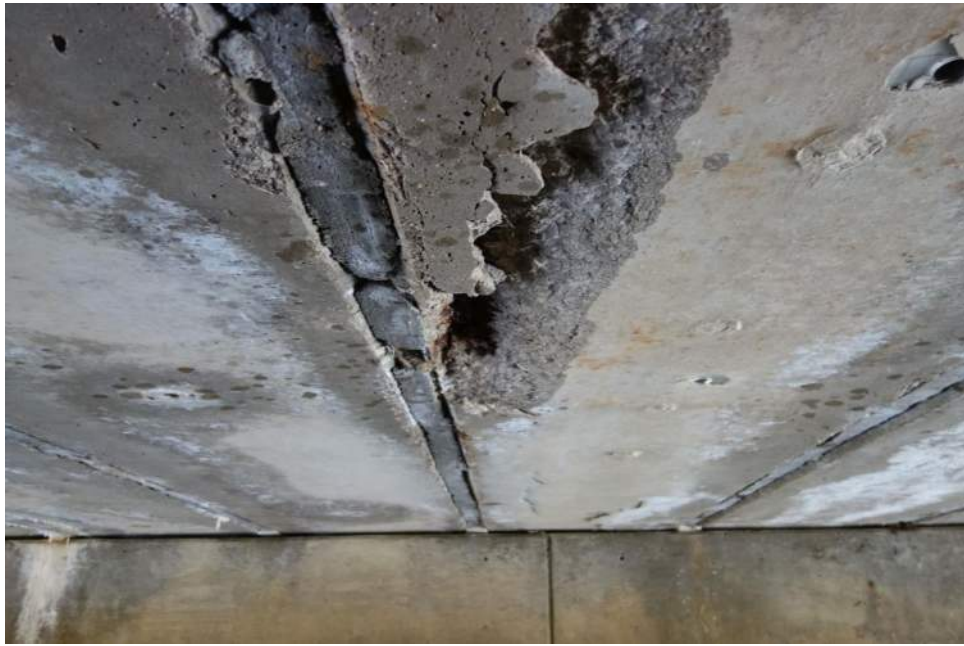
Beam 7W Delamination and Broken Strand
