# HISTORIC DISTRICT COMMISSION MEETING AGENDA

To: Historic District Commission  
From: R. Brent Savidant, Planning Director  
Subject: Notice to Proceed – Demolition of Building Additions – Old Stone School –  
3995 South Boulevard

Linda Rivetto  
Principles of Preservation Technology  
GHPR591  
Exterior Assessment Conditions Report  
8 March 2004

# **OLD STONE SCHOOL**

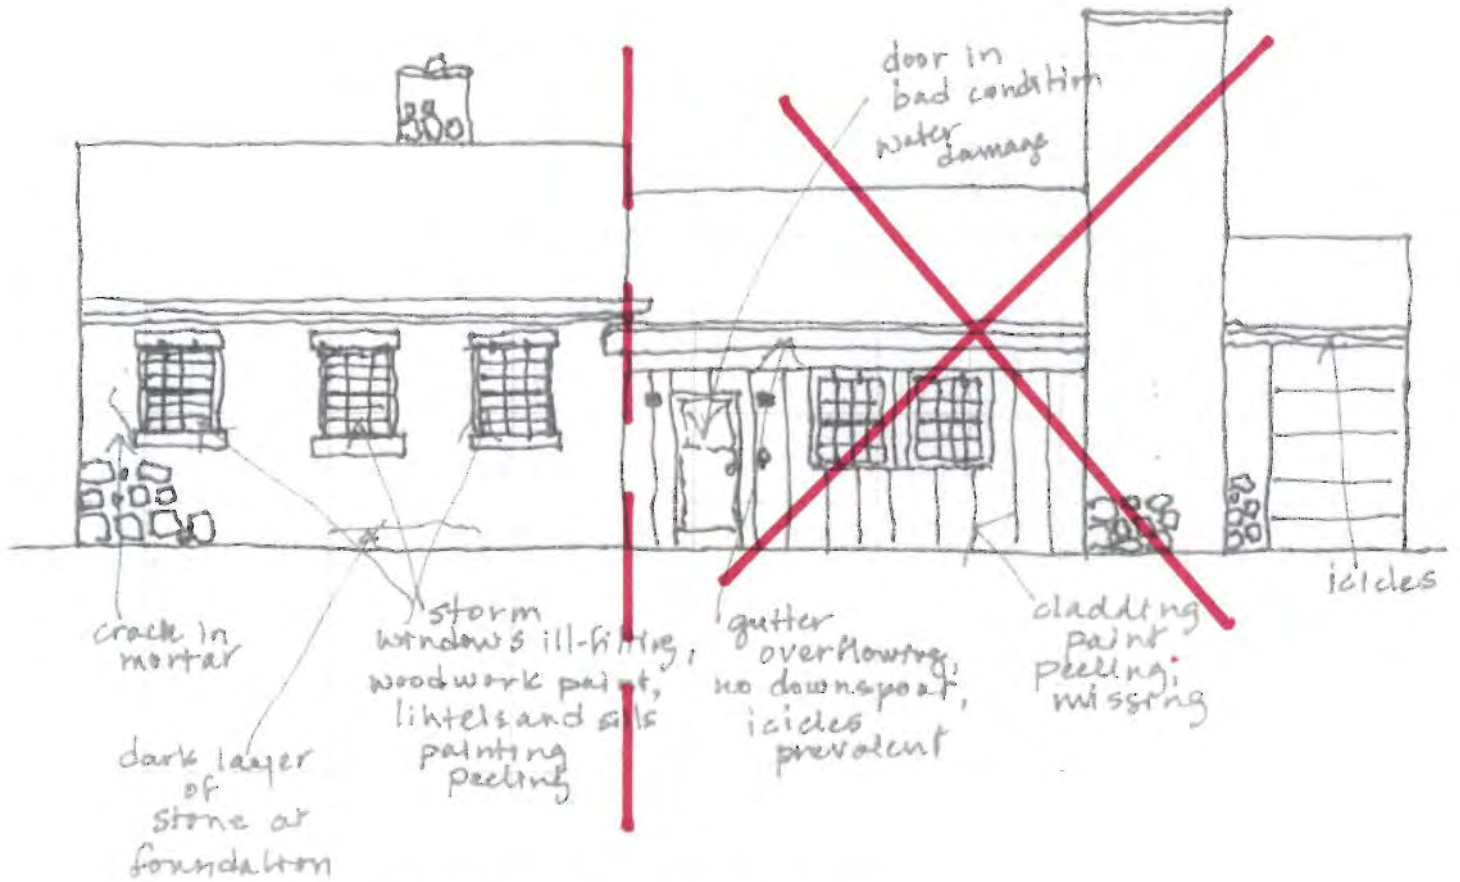
Drawing No. 2

**Demolish Non-Historic  
Addition**

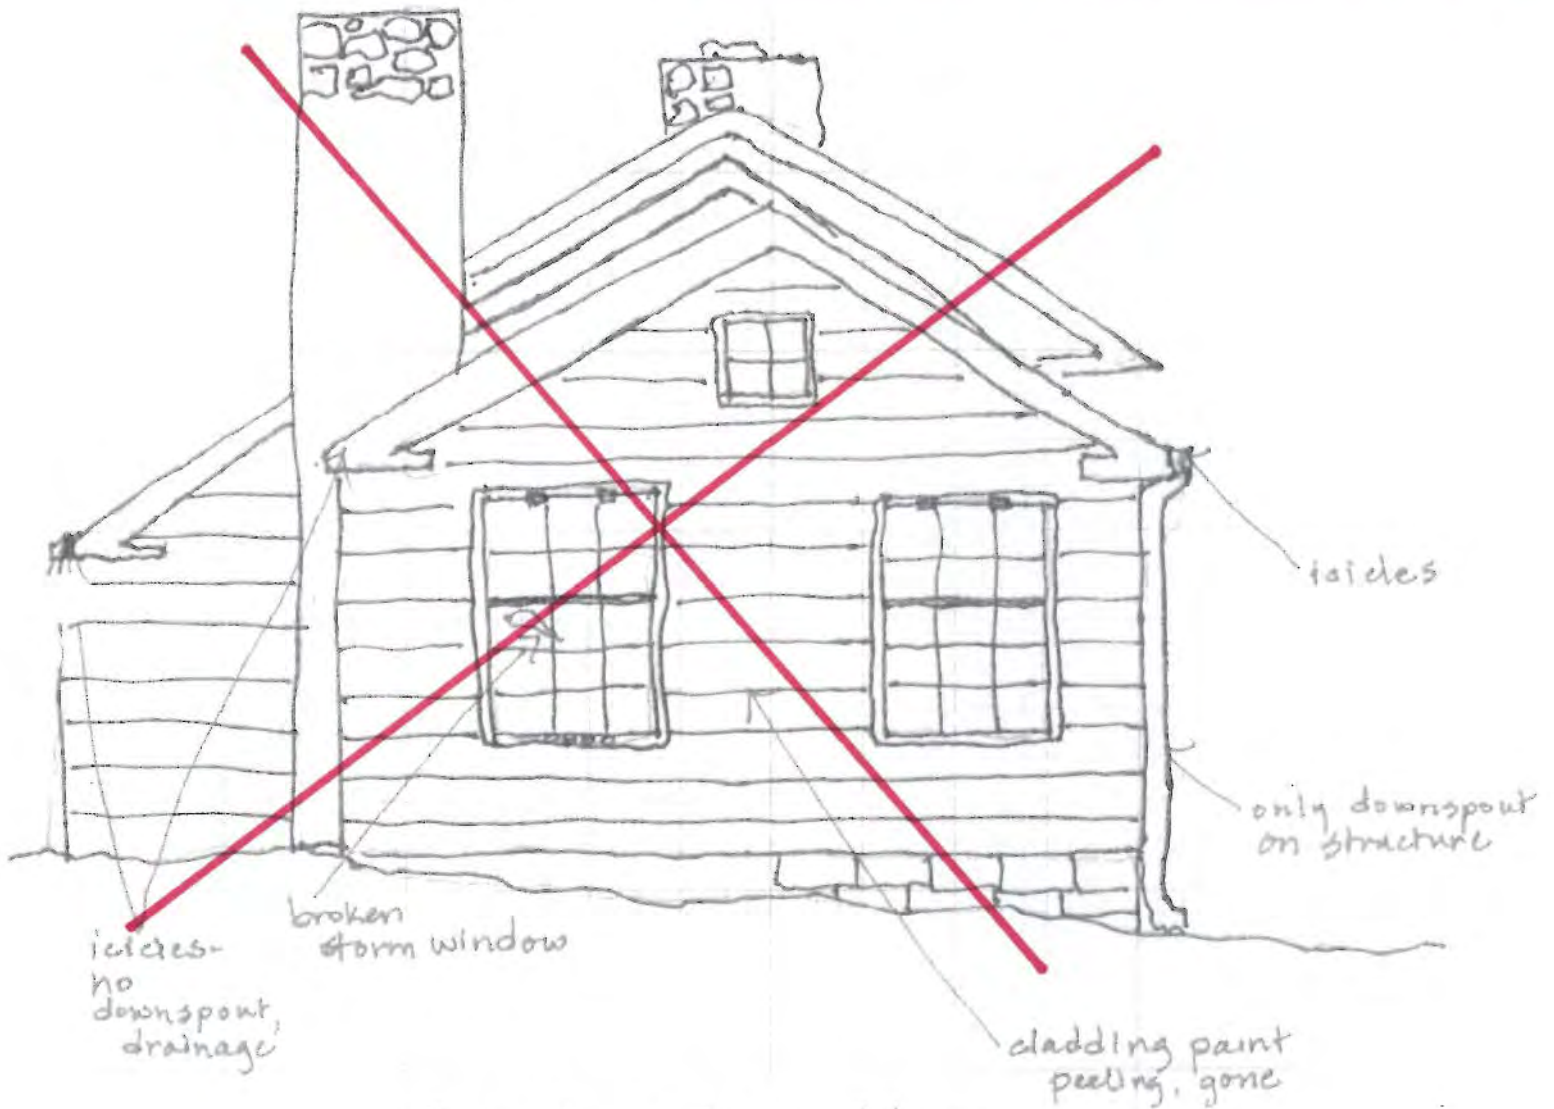
# Demo South Addition

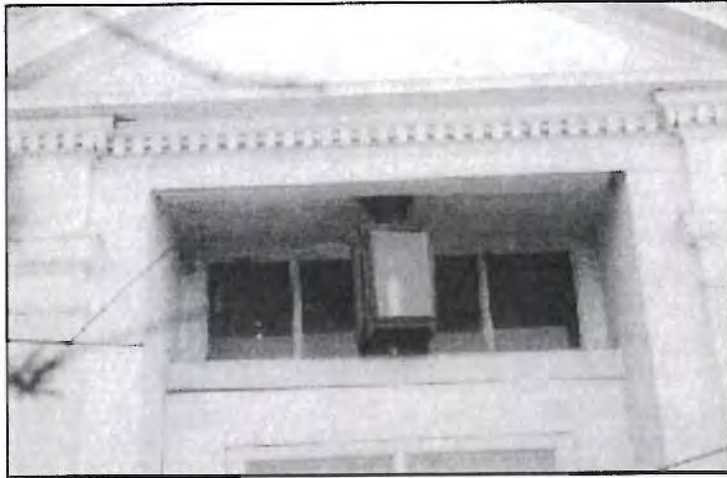
Photo No. 5  
Front Door Transom  
Stone School

Doors: There are three doors on the main building, the main entry door to the schoolhouse, which is no longer actively used, and one door on the east and on the west side of the addition. The east door is not at ground level and has no steps outside of it, so it presumably is no longer used. The schoolhouse door is the original paneled oak door, with a pedimented gable, pilasters, recessed transom lights, and dentil molding (photo 5). There is a

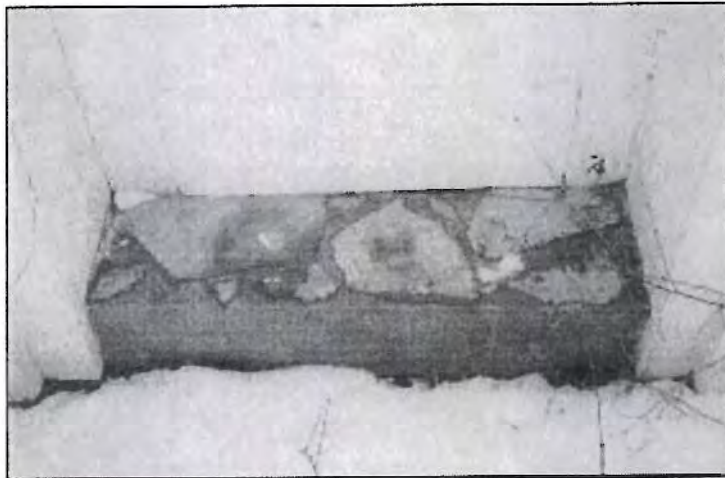
Photo No. 6  
Stone Door Sill  
Stone School

small front porch in front of the door and a step up to enter the door, onto a stone doorsill (photo 6). The east door is wood panel with 6 windowpanes (photo 7). The west door appears to be an interior luan door (photo 8). There is a small step up to enter this door. All doors have storm doors, wood on the original front door, metal on the two of the addition.

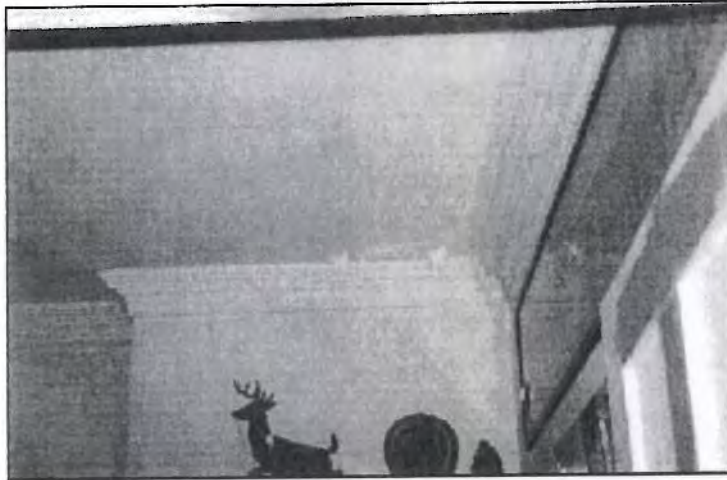
Photo No.9  
Dining room Ceiling  
Stone School

Roof: The DeGioias replaced the roofs on all the structures in 1979, after they moved in. The exterior of the roof of the schoolhouse building appears to be basically sound, although the roof is about 26 years old. However, a brief interior inspection of the stone building revealed peeling paint on the ceiling of the dining room section of the house, an indication of potential leakages in that area of the roof (photo 9). The cornice line shows weathering with peeling and absent paint (photo 10). In the winter, after a big snowstorm, there are ice dams and icicles at each roofline (photos 11, 12). The gutter on the east side of the house is pulling away from the roofline. And with only one downspout in evidence, despite the existence of a gutter on the west side of the building, water drainage from the roof is definitely questionable.
