Historic District Committee- Agenda Item

Date: February 12, 2021
To: Historic District Commission Members
From: R. Brent Savidant, Community Development Director
Subject: Demolition of Outhouse – Old Stone School (3995 W. South Boulevard)

Linda Rivetto
Principles of Preservation Technology
GHPR591
Exterior Assessment Conditions Report
8 March 2004

Historic Outhouse Inspection Report

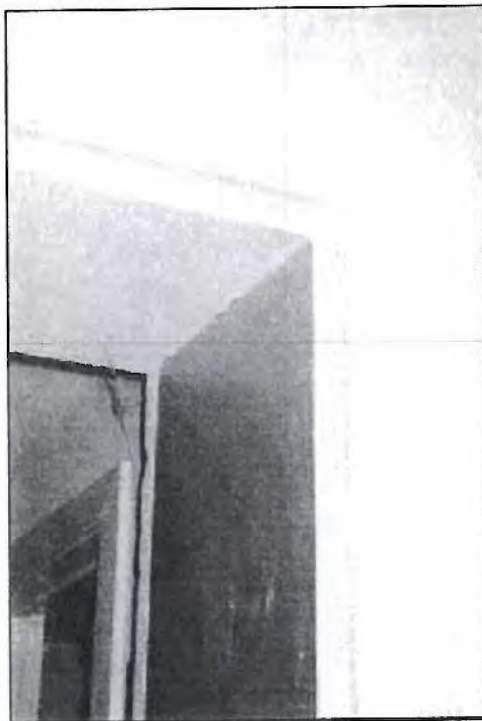
Photo No. 4
Wall Depth
Stone School

Walls: The walls of the stone school portion of the building, as well as of the outhouse and well, are made of mortared local fieldstone, in coursed rubble construction (McAlester 38-9). These walls are 20 inches thick (photo 4). The addition to the schoolhouse is wood-clad, using both horizontal and vertical boards.

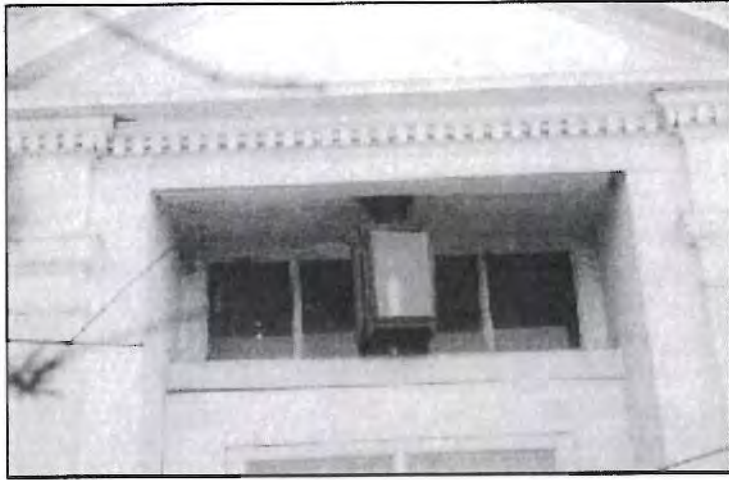
Photo No. 5
Front Door Transom
Stone School

Doors: There are three doors on the main building, the main entry door to the schoolhouse, which is no longer actively used, and one door on the east and on the west side of the addition. The east door is not at ground level and has no steps outside of it, so it presumably is no longer used. The schoolhouse door is the original paneled oak door, with a pedimented gable, pilasters, recessed transom lights, and dentil molding (photo 5). There is a

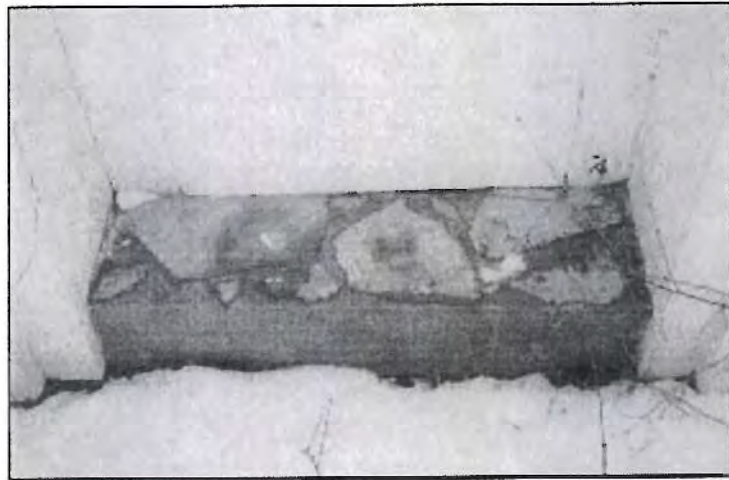
Photo No. 6
Stone Door Sill
Stone School

small front porch in front of the door and a step up to enter the door, onto a stone doorsill (photo 6). The east door is wood panel with 6 windowpanes (photo 7). The west door appears to be an interior luan door (photo 8). There is a small step up to enter this door. All doors have storm doors, wood on the original front door, metal on the two of the addition.

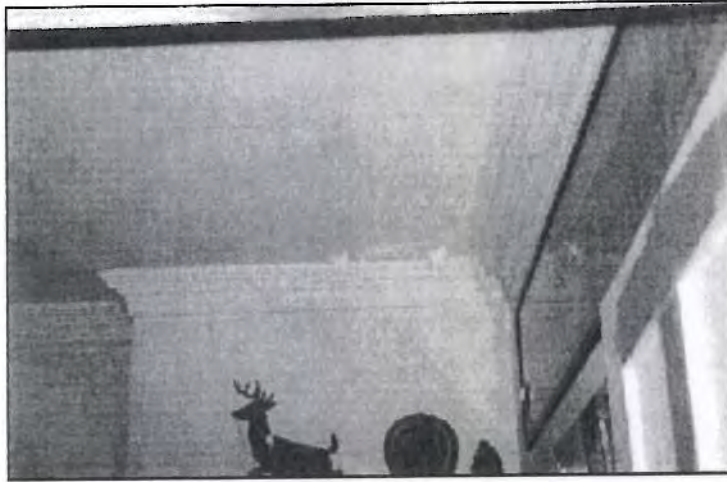
Photo No.9
Dining room Ceiling
Stone School

Roof: The DeGioias replaced the roofs on all the structures in 1979, after they moved in. The exterior of the roof of the schoolhouse building appears to be basically sound, although the roof is about 26 years old. However, a brief interior inspection of the stone building revealed peeling paint on the ceiling of the dining room section of the house, an indication of potential leakages in that area of the roof (photo 9). The cornice line shows weathering with peeling and absent paint (photo 10). In the winter, after a big snowstorm, there are ice dams and icicles at each roofline (photos 11, 12). The gutter on the east side of the house is pulling away from the roofline. And with only one downspout in evidence, despite the existence of a gutter on the west side of the building, water drainage from the roof is definitely questionable.
