# **CITY COUNCIL AGENDA ITEM**

RE: Proposal for Professional Services Troy Historic Village – Wagon Shop

## Troy Historic Village Wagon Shop Structural Assessment

60 West Wattles Road, Troy, MI 48098 WJE No. 2021.5313

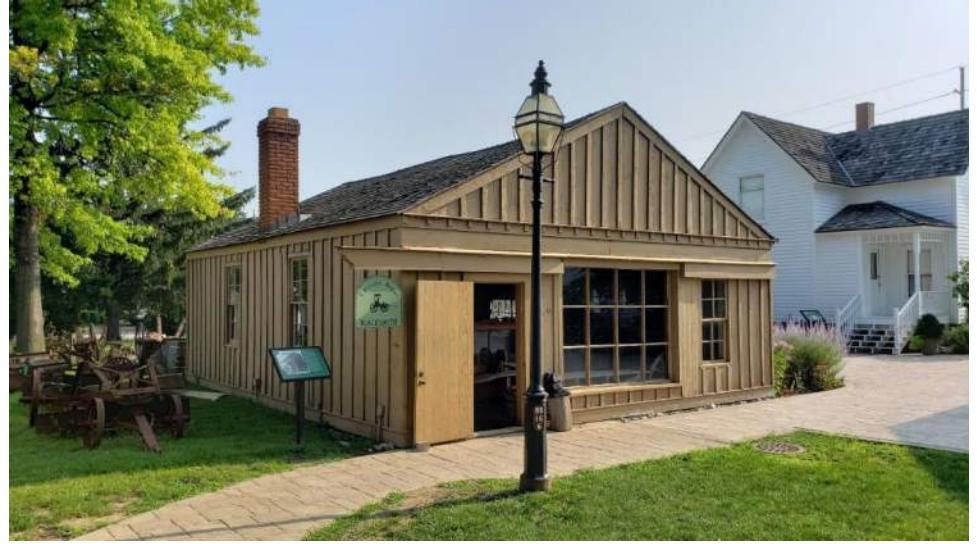
The Wagon Shop (Figure 1) is a wood framed building that was reportedly constructed around the mid-1800s and relocated in the 1980s, after a fire event, from a local farm to the Troy Historic Village. The less than 1,000 square foot building has a gable roof with the ridge parallel to the longer sides of the rectangular footprint. A loft floor is located on the front (south) half of the building. A brick masonry chimney extends through the roof level at the west wall. There are larger window and door openings in the north and south gable end walls, and smaller window openings in the east and west bearing walls.

Figure 1. Overall view of the Wagon Shop, looking from the southwest corner of the building.

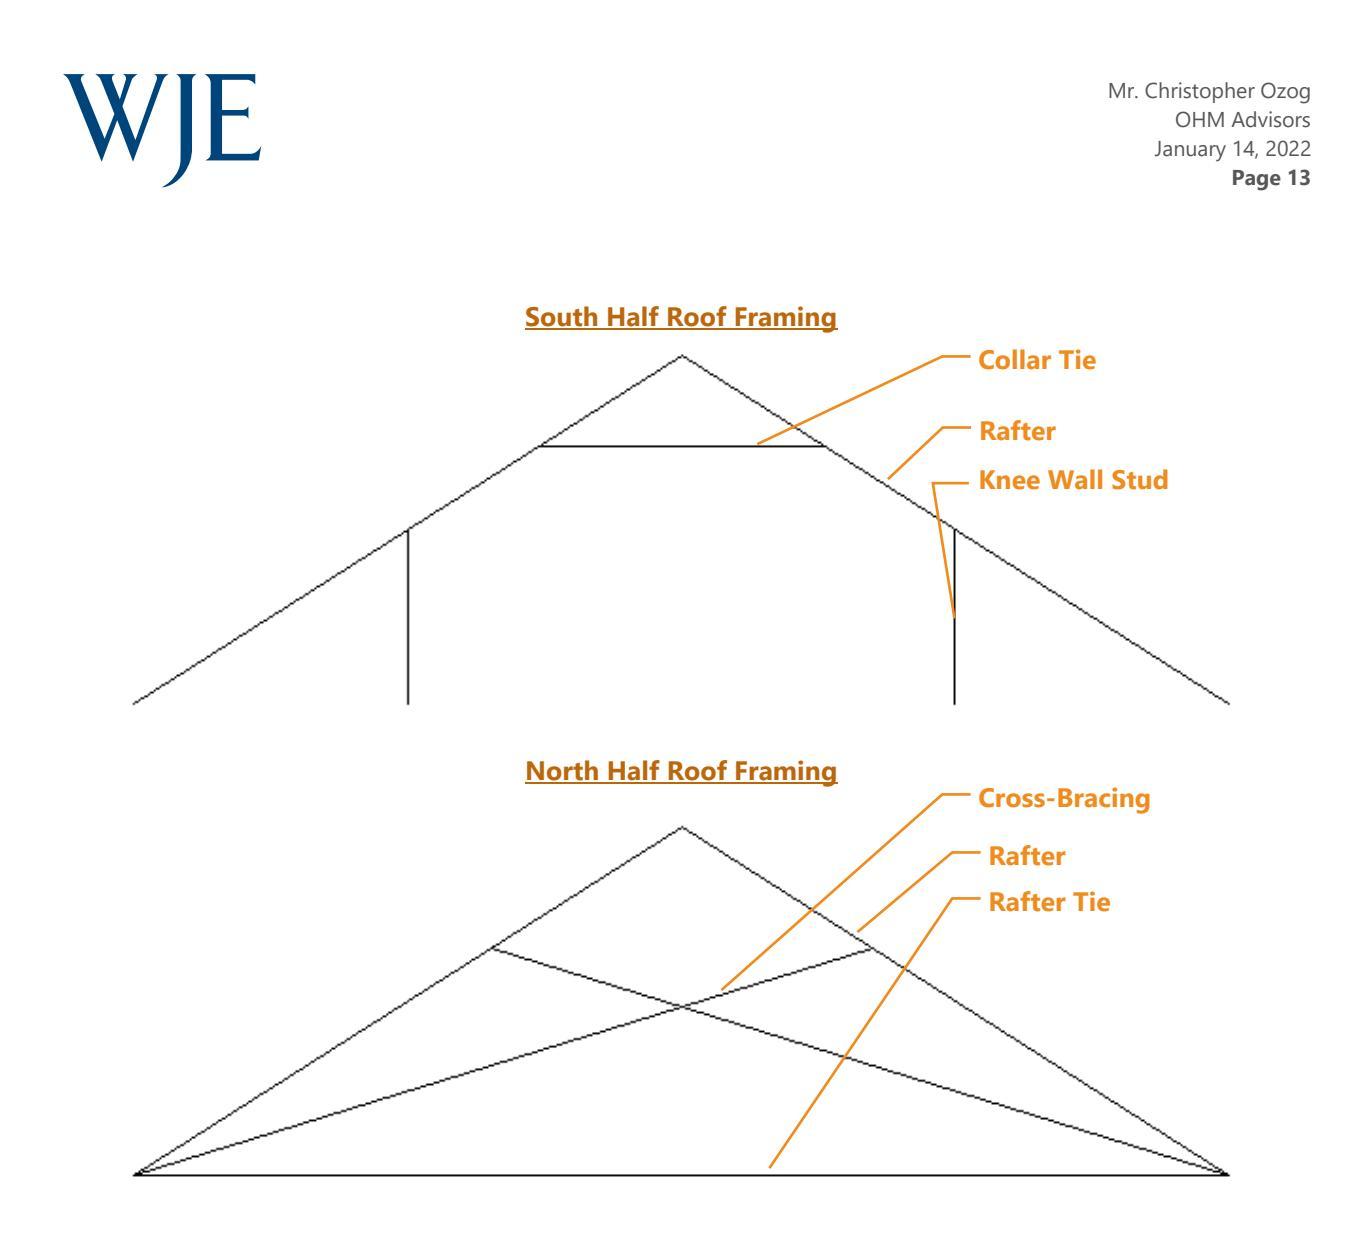
- 4. The roof framing supports cedar shingles that are attached to 3/4-inch wood plank decking. The roof framing is generally at an 8 on 12 slope and is approximately 7-foot in total depth, spanning approximately 23 feet between the east and west walls. The framing differs between the north and south halves of the building as described below. Refer to Figure 5 for general elevations of the two framing systems.

Figure 5. Typical roof framing systems. The lines represent wood members.

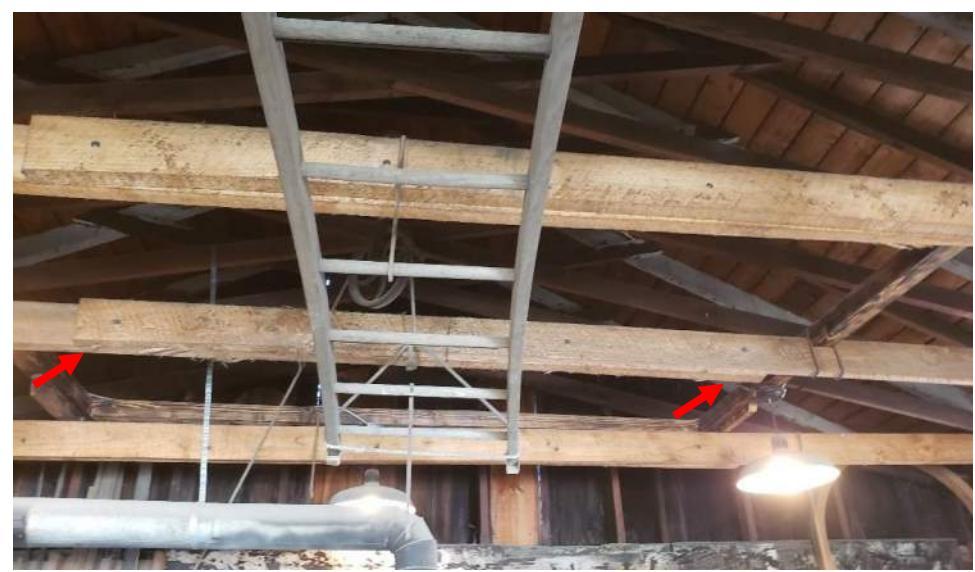
- ii. At the ridge, the vertical surfaces of the rafters, at the abutting ends, are not always painted (Figure 8).
    - iii. The rafter ties are lapped and bolted together near mid span with four, 5/16 inch diameter bolts, except for the northmost rafter tie, which is bolted with five bolts (Figure 9).

Figure 9. Rafter ties bolted and lapped.

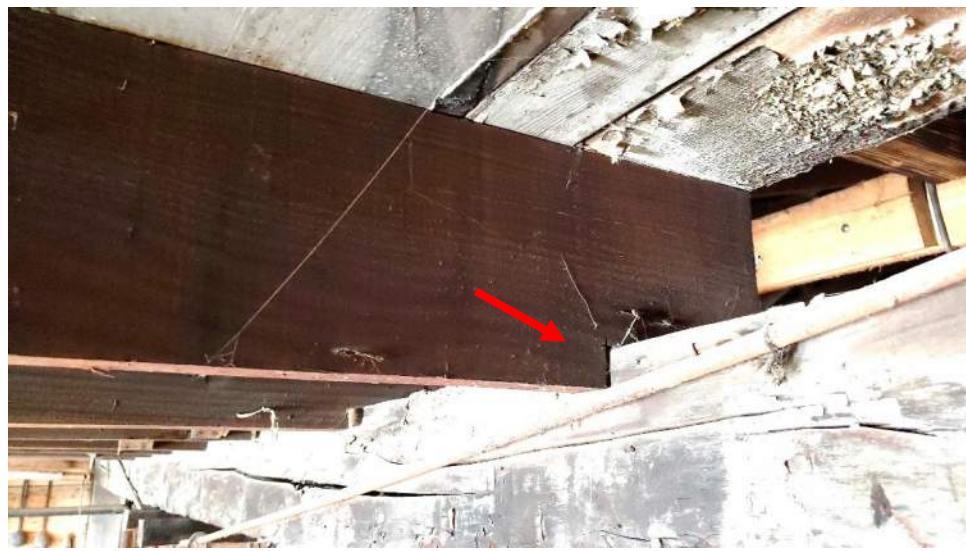
6. The wood plank flooring of the loft is supported by nominal 2x8 joists spanning between the south exterior wall and center 7x7 timber beam. The joists are notched over the top of the center beam and wall top plate timber. The depth of the notch is approximately 1-1/4 inch (Figure 15), except where

Figure 15. Typical notch in loft area joist bearing end.

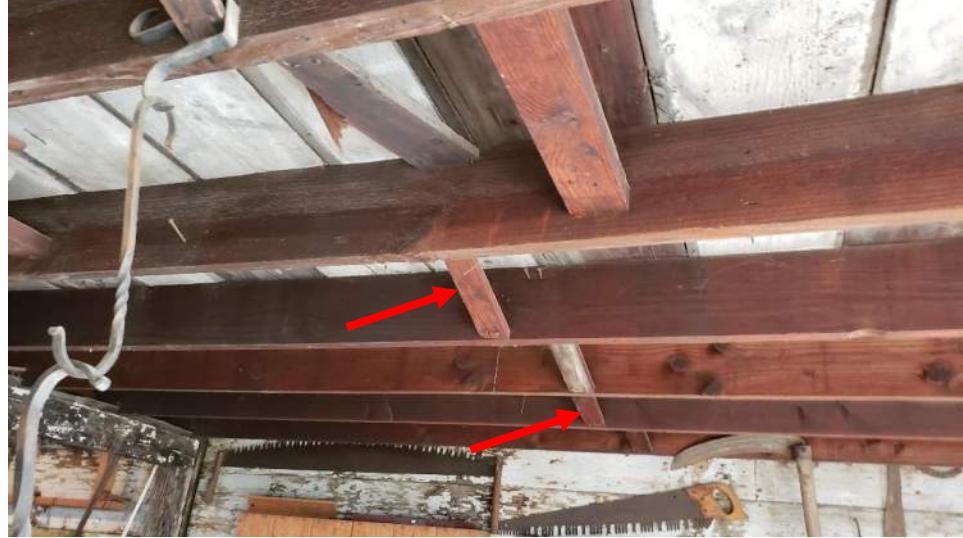
- 7. Cross-bridging is located at midspan of the loft floor joists. (Figure 17).
- 8. A partial depth fracture is located near midspan of the fifth joist as counted from the east wall. The fracture extends from a knot on the bottom edge of the wood member where the fracture is widest (Figure 18).

Figure 17. Cross-bridging at the loft floor joists.

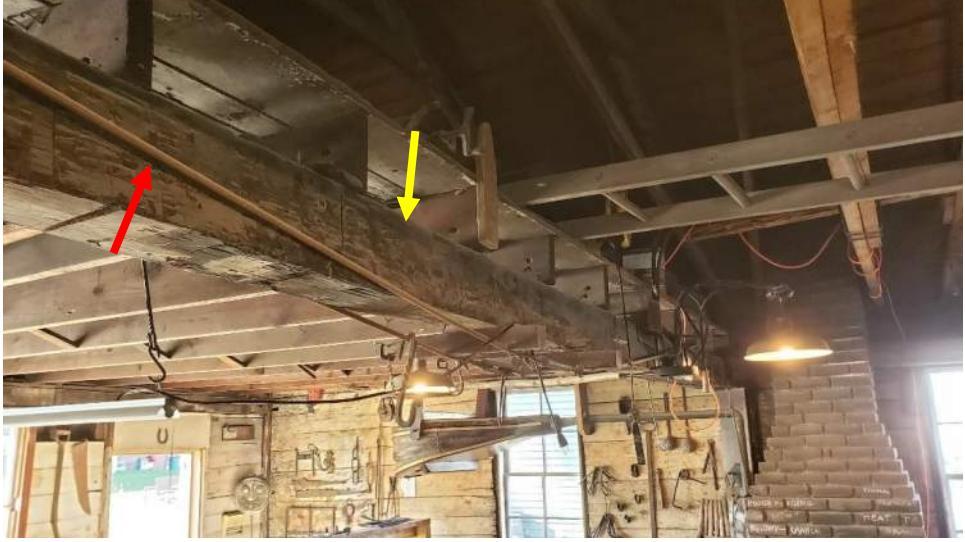
- 9. The center beam is a hand-hewn timber reinforced with 1/2-inch diameter metal tension rods to create a composite "truss" with a 19-inch depth at midspan (Figure 19). The tension rods are secured with washers and double nuts at the top, exterior surface of the east and west walls and turnbuckles at midspan.

Figure 19. Post-tensioned 'truss" comprised of timber (yellow arrow) and tension rods (red arrow).

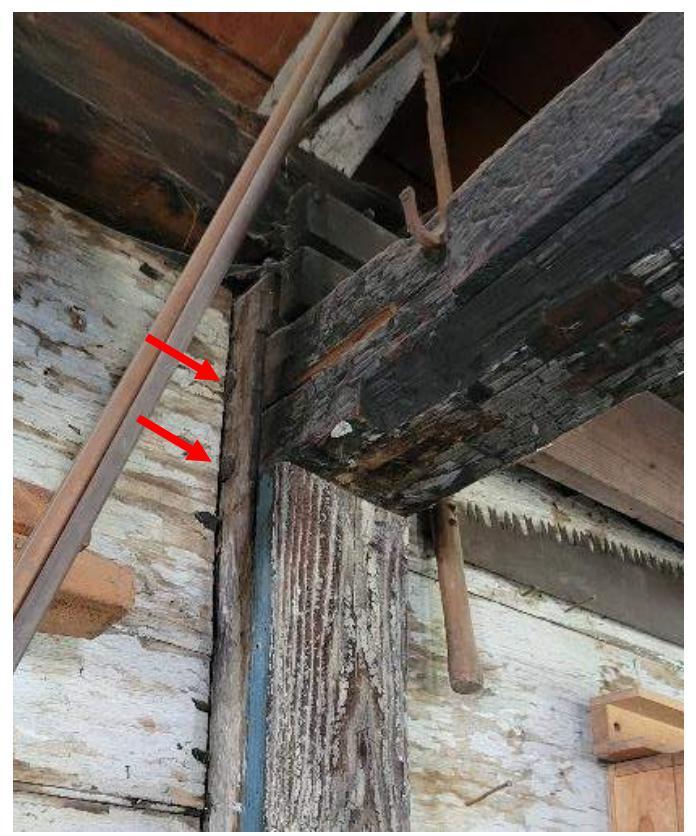
- 10. The center beam is connected to 7x7 timber columns through a mortise and tenon joint with wood trennels (i.e., wood dowel "nails") visible on the sides of the beam (Figure 24). A 2x wood member, secured to the interior face of each of the columns, provides an additional 1-1/2 inches of bearing for the center beam.

Figure 24. Wood trennels on side of column (arrows).
